***ST. PHILIPS ANGLICAN CHURCH
BUILDING CONDITION ASSESSMENT
& CAPITAL PLAN***

**Presented to:
The Board
St Philips Anglican Church**

November 29, 2017

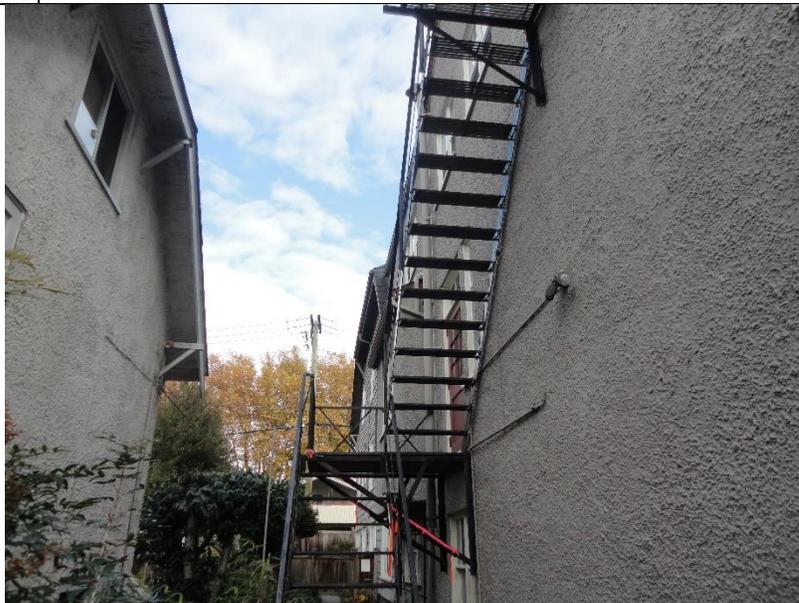
Component (1) Superstructure													
Building Component	Steel fire escape stairs – 2 locations												
Description	The steel stairs are located at the side of the building and to the back to the caretaker’s unit. They consist of two flights plus a landing for each stairs.												
Overall Condition	Good – require painting in the short term												
Life Cycle Analysis

Installation date	1990 (installed) 2011 (painting) - assumed	Life expectancy	60 years	Chronological age	27 years	Effective Age	27 years	Remaining life span	33 years	Maintenance year	2018 and every 5 years after
Installation date	1990 (installed) 2011 (painting) - assumed												
Life expectancy	60 years												
Chronological age	27 years												
Effective Age	27 years												
Remaining life span	33 years												
Maintenance year	2018 and every 5 years after												
Unit Quantity	Two flights and one landing 2 items												
Current maintenance cost	Painting and decorating of stairs - \$400 1 stairs - 5 hrs @ \$30 per hr (labour) = \$150 + material (\$50) = \$200 per stairs.												
Commentary	The actual stairs structure is performing satisfactorily. No major defects were observed or reported. They require painting in the short term. This work is expected to be completed by maintenance staff on site. If a contractor is hired, this will most likely result in higher costs.

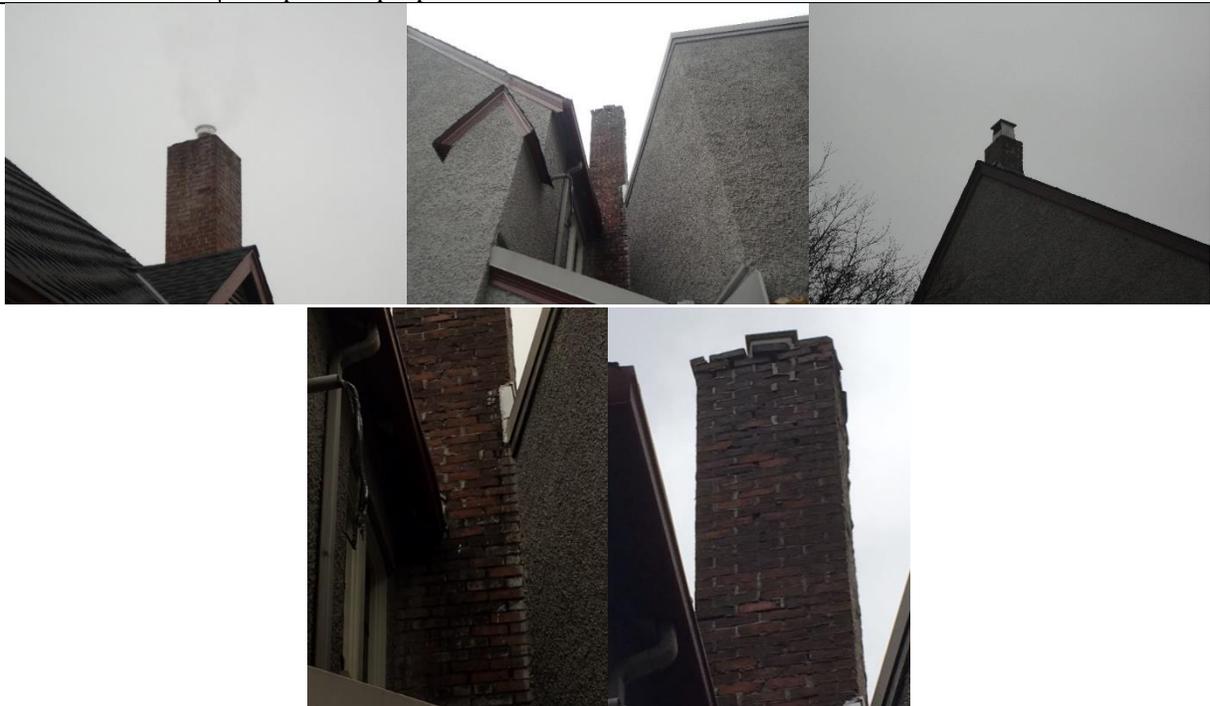
Component (2) Brick Chimney													
Building Component	Brick Chimneys												
Description	There are three red masonry brick chimneys in the building. One is located to the east side of the building, one to the west side of the building and the other is located in the middle above the boiler room.												
Overall Condition	Poor												
Life Cycle Analysis

Installation date	1928 & 1941	Life expectancy	75 years	Chronological age	76 & 89 years	Effective Age	74 years	Remaining life span	1 year	Replacement year	2018
Installation date	1928 & 1941												
Life expectancy	75 years												
Chronological age	76 & 89 years												
Effective Age	74 years												
Remaining life span	1 year												
Replacement year	2018												
Unit Quantity	Brick chimneys 3 items												
Current repair/replacement cost	Remove east chimney - \$6,037.50 Repair & re-point middle chimney - \$10,080.00 Alternative budget for reconstruction of middle chimney - \$17,700												
Commentary	The three chimneys are the original. Two of the chimneys are showing significant signs of deterioration. The east chimney is obsolete, and the boiler room chimney is still in use. We recommend budgeting to remove the east chimney and to re-point the Boiler Room chimney in the short term. The chimney that requires removal appears to be very hazardous and should be completed as soon as possible. Dunbar masonry have provided budget numbers for this work. They have also provided a budget to knock and re-build the middle chimney which is far costlier project (\$17,700). We have budgeted for re-pointing the brick at this stage. The west side chimney to the fireside room is performing satisfactorily and no work is required currently. We also recommend obtaining another quotation for this work for comparison purposes.

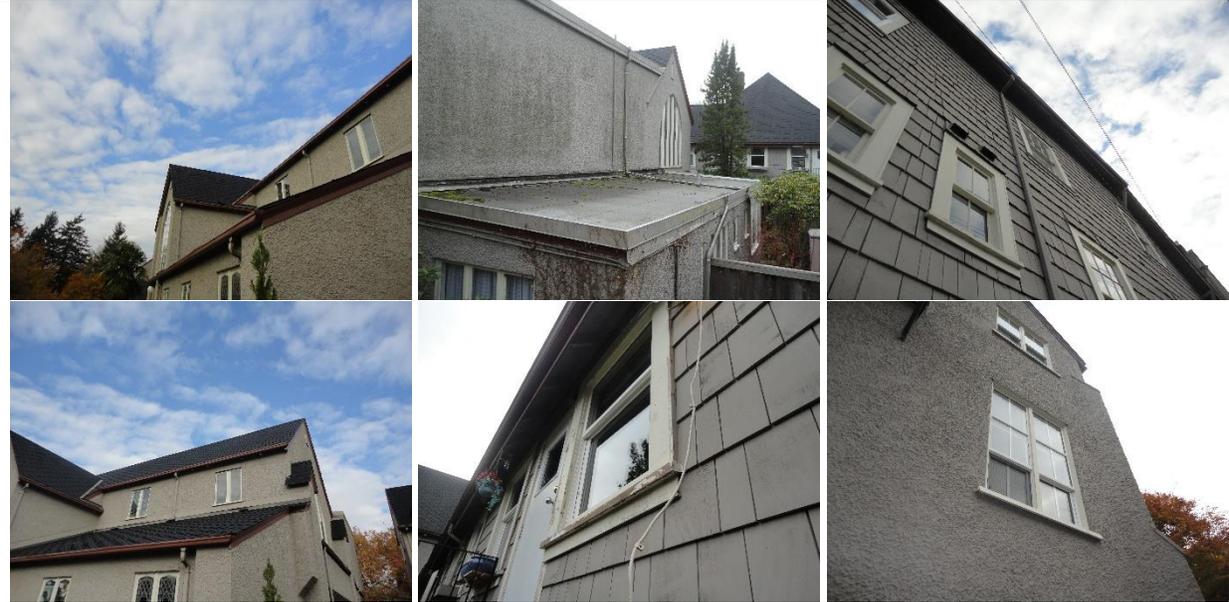
Component (3) Stucco and cedar siding

Building Component	Slop dash stucco siding and cedar siding	
Description	The front and the sides of the buildings consist of stucco siding. The back of the building consists of cedar siding.	
Overall Condition	The stucco and siding are generally in good condition.	
Life Cycle Analysis	Installation date	1941
	Life expectancy	75 years
	Chronological age	76 years
	Effective Age	55 & 75 years
	Remaining life span	1 & 20 years
	Replacement year	2018 & 2037
Unit Quantity	Envelope	Approximately 13,400 sf
Current repair/replacement cost	Removal	\$5.00
	Supply and install stucco and siding	\$15.00
	Subtotal including profit & OH	\$20.00
	GST @ 5%	\$1.00
	Total per sf of roofing	\$21.00 per sf
	Total 12,400 sf	\$260,400
	Total 1,000 sf	\$21,000
Commentary	No major defects were observed or reported with the majority of the stucco and siding. One section to the gable on the east side at the front was recently replaced due to leaking from the roof. The building was also recently fully repainted. The back north-east corner of the building is showing signs of deterioration. The stucco is showing visible signs of moisture penetration. This was reported on site to be similar to the issues observed on the gable before replacement was required there. We recommend budgeting to replace this section of stucco in the short term. A full replacement of the stucco can be postponed for approximately twenty years. Regular inspections and maintenance are recommended. A Building Envelope Condition Assessment is also suggested at some point in time as a visual non-intrusive inspection is insufficient to determine if the stucco has any moisture penetration.

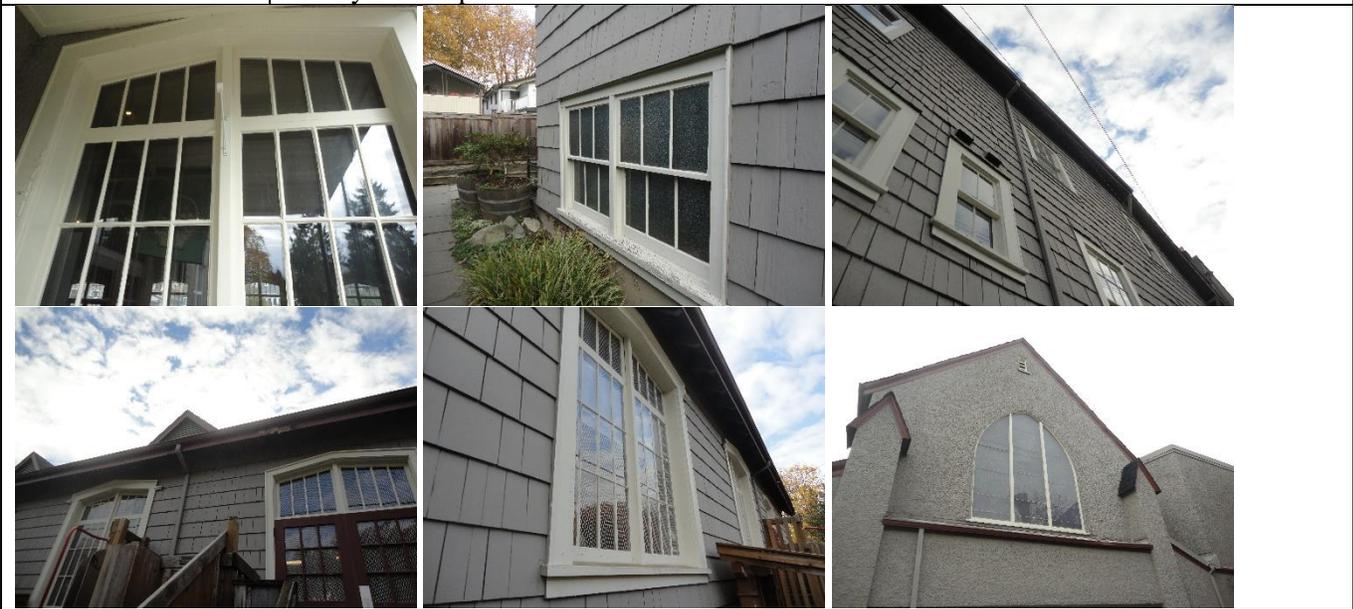
Component (4) Windows

Building Component	Wooden framed single glazed windows and vinyl framed double glazed windows	
Description	The hall and church building contain wooden framed single glazed windows and the office and fire side room contains vinyl framed double glazed windows	
Overall Condition	Good condition	
Life Cycle Analysis	Installation date	(Wooden) 1941 & (Vinyl) 1997
	Life expectancy	(Wooden) 60 years & (Vinyl) 35 years
	Chronological age	76 & 20 years
	Effective Age	Daycare/office 50, Church 40 & Vinyl 20 years
	Remaining life span	10, 20 & 15 years
	Replacement Year	2027, 2037 & 2032
Unit Quantity	Wooden framed	46 ea
	Wooden framed – church (large)	9 ea
	Wooden framed – church (small)	22 ea
	Vinyl framed double glazed	24 ea
Current repair/replacement cost	Wooden framed windows - \$138,000 Wooden framed – church (large) - \$180,000 Wooden framed – church (small) - \$154,000 Vinyl framed double glazed - \$60,000 Painting window trims - \$8,080

Commentary	The wooden framed single glazed windows to the main hall and west side of the building are the original. They are single glazed but internal panels have been added to them in order to prevent damaged by play in the hall. Despite their age, they are still functioning satisfactorily. The single glazed stained windows to the church are also the original and are also functioning satisfactorily. The frames to all the windows require painting within the next year. It was reported that they were previously painted but poor workmanship was completed. It appears that they were not primed properly as peeling is occurring on nearly all frames. The vinyl framed double glazed windows are performing satisfactorily as they were replaced in or around 1997.

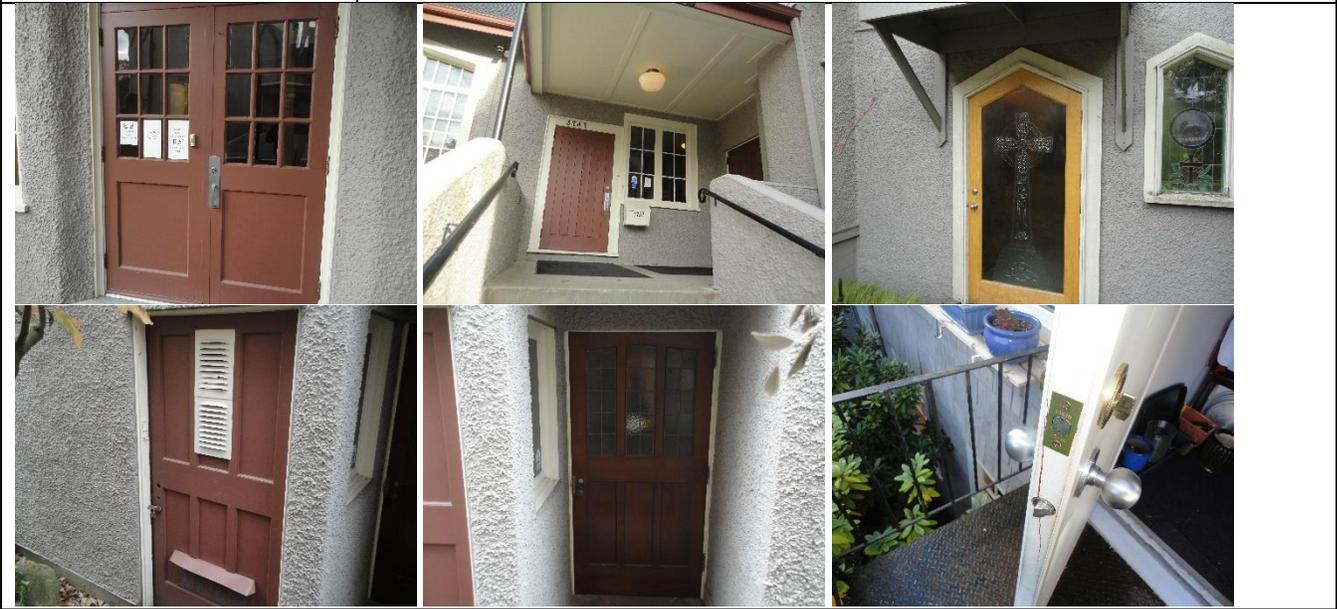
Component (5) Doors		
Building Component	Exterior Doors	
Description	Solid wooden swing doors with glazed panels, metal clad swing door and hollow-core steel door.	
Overall Condition	Wood and steel doors- good, Metal clad door – poor	
Life Cycle Analysis	Installation date	Wooden 1960(assumed), metal clad 2012 & hollow-core steel door 1960.
	Life expectancy	(Wooden) 50 & (Metal clad) 35 years.
	Chronological age	57 & 5 years
	Effective Age	(Wooden) 30, (Hollow-core steel) 35 & (metal clad) 7
	Remaining life span Replacement year	20, 15 & 28 years 2037, 2032 & 2045
Unit Quantity	Solid wooden swing doors	18 lvs (double and single)
	Hollow-core steel door	1 ea
	Metal clad swing door	1 ea
Current repair/replacement cost	Solid wooden swing doors - \$72,000 Hollow-core steel door - \$2,000 Metal clad swing door - \$1,000	
Commentary	The majority of doors are performing satisfactorily. No major defects were observed or reported. Painting of doors can be completed in conjunction with the exterior wall painting. The door to the caretaker’s suite is damaged. The wooden interior is cracked. The door should be replaced in the short term.

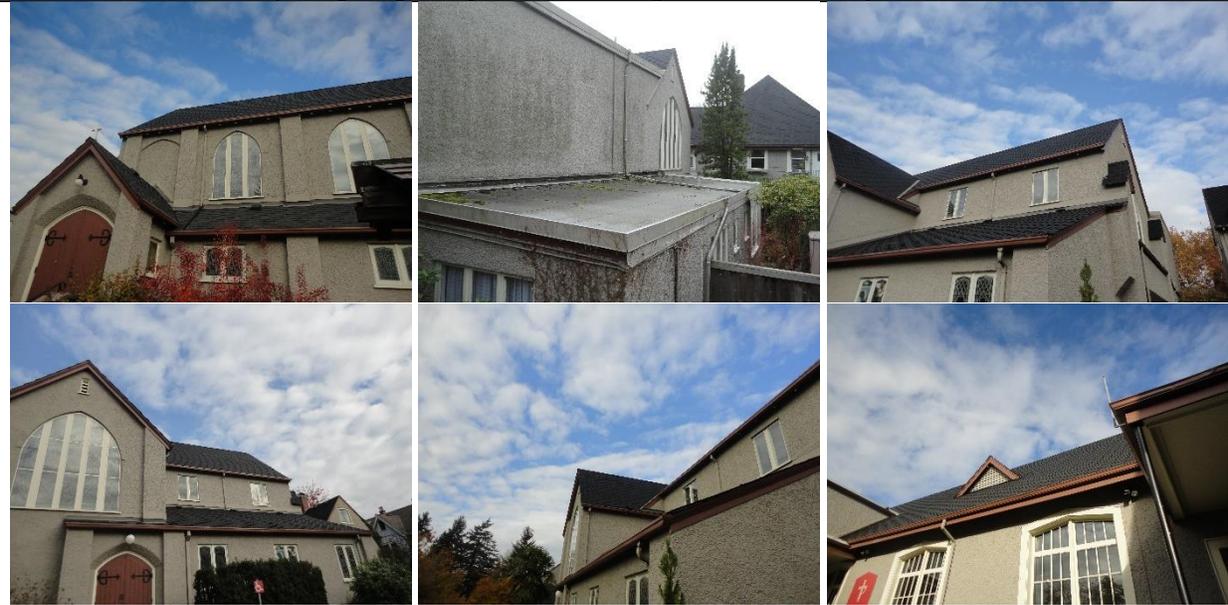
Component (6) Roofing		
Building Component	Sloped and flat roofing	
Description	The sloped roofing consists of asphalt shingles and the flat roofing consists of two-ply SBS bitumen membrane.	
Overall Condition	Good and poor	
Life Cycle Analysis	Installation date	1999 & 2014
	Life expectancy	22 years
	Chronological age	18 & 3 years
	Effective Age	(Sloped East side) 21 years, (Sloped & Flat to West side) 3 years & (Flat East side) 17 years
	Remaining life span	1, 19 & 5 years
	Replacement year	2018, 2036 & 2022
Unit Quantity	Sloped roofing - old	15,000 sf
	Sloped roofing - new	1,900 sf
	Flat roofing - old	1,800 sf
	Flat roofing - new	1,025 sf
Current replacement cost	Sloped roofing (old) - \$78,750 Sloped roofing (new) - \$9,975 Flat roofing (old) - \$27,000 Flat roofing (new) - \$15,375	
Commentary	<p>The sloped roofing with asphalt shingles to the west side of the building over the offices and a small section over the chapel was recently replaced. The roof is performing satisfactorily. The sloped roofing over the main hall and the church is old and past design life expectancy. It is planned for replacement within the next year. Regan roofing have provided a budget for the new roofing. The flat roofing to the church is approximately 17 years old but is performing satisfactorily. We recommend budgeting to replace the roofing here within five years.</p>

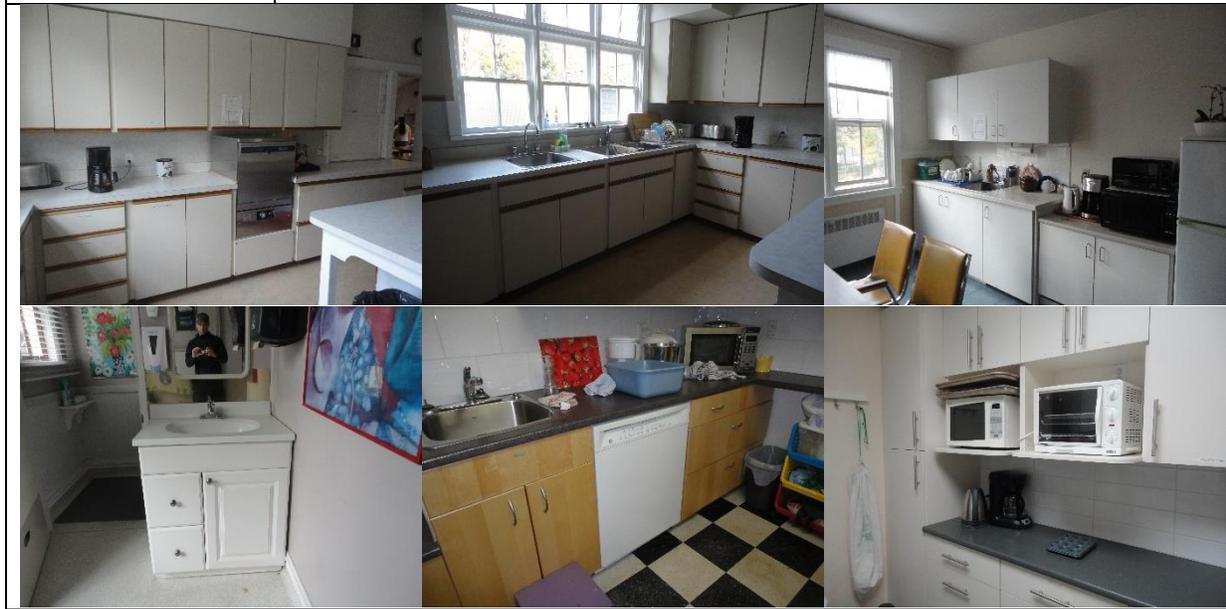
Component (7) Fittings		
Building Component	Kitchen and washroom cabinetry fittings.	
Description	Wooden compressed particle cabinetry, solid wooden cabinetry, countertops, hardware etc.	
Overall Condition	Fair & Good condition	
Life Cycle Analysis	Installation date	(Main kitchen & church) 1980, (Office) 1990, (Caretakers) 2012, (Washroom & Daycare 2) 2010 and (Daycare 1) 2005.
	Life expectancy	30 years
	Chronological age	37, 27, 5, 37, 7 & 12 years.
	Effective Age	25, 20, 5, 22, 7 & 12 years
	Remaining life span	5, 10, 20, 8, 23 & 18 years
	Replacement year	(Main kitchen) 2022, (Office) 2027, (Caretakers) 2037, Sacristy (2025), (Washroom) 2040, (Daycare 1) 2045 & Daycare 2 (2040).
Unit Quantity	Cabinetry	6 locations
Current repair/replacement cost	Main kitchen - \$7,000 Office kitchen - \$3,000 Caretakers suite - \$6,000 Church sacristy cabinetry - \$6,000 Washroom cabinetry - \$2,000 Pre-school cabinetry (Crown) - \$12,000 Pre-school cabinetry (Tom Thumb) - \$20,000

Commentary	No major defects were observed or reported with any of the cabinetry. It is all performing satisfactorily. The next location that should be considered for replacement or re-facing is the kitchen on the main floor. This location receives the most usage. We have allowed to reface all the cabinetry here.

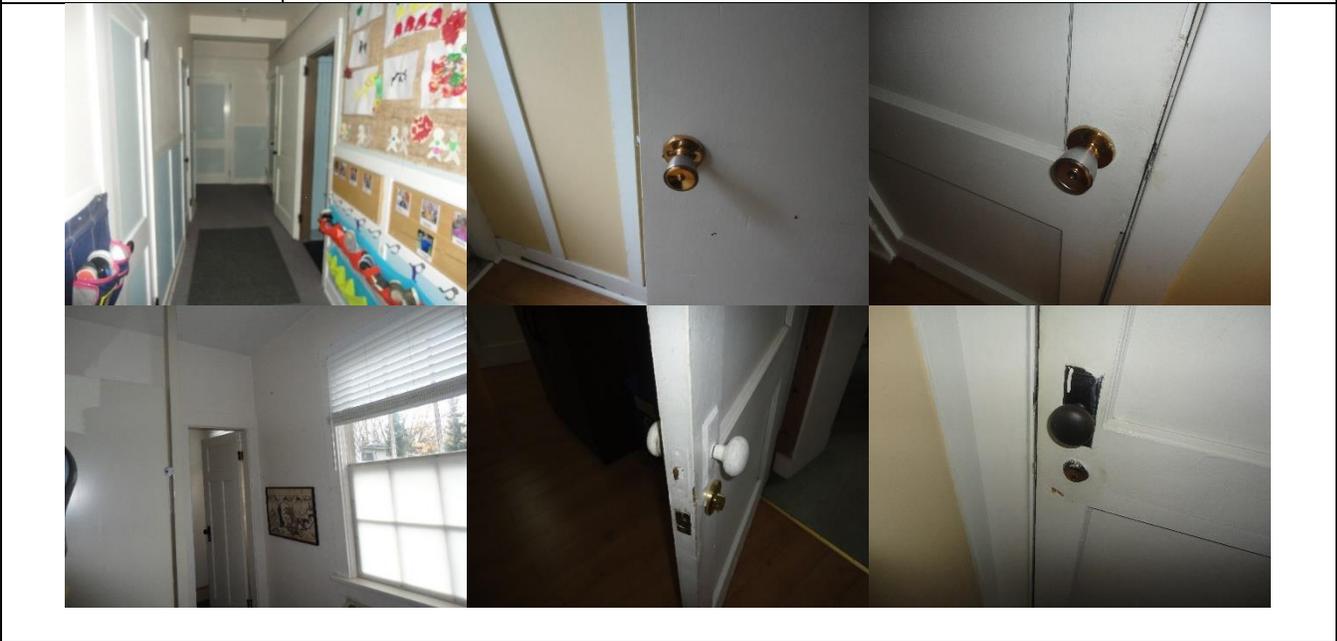
Component (8) Interior doors hardware													
Building Component	Solid wooden swing doors, frames, hardware etc.												
Description	The interior doors consist of original solid wooden swing doors with metal hardware.												
Overall Condition	Doors – good, hardware - poor												
Life Cycle Analysis	<table border="1"> <tr> <td>Installation date</td> <td>1941</td> </tr> <tr> <td>Life expectancy</td> <td>Doors (60), hardware (35), painting (15) years.</td> </tr> <tr> <td>Chronological age</td> <td>Doors - 76, Hardware – 57, Painting – 17 years.</td> </tr> <tr> <td>Effective Age</td> <td>Doors - 30, Hardware – 33, Painting – 14 years.</td> </tr> <tr> <td>Remaining life span</td> <td>Doors - 30, Hardware – 2, Painting – 1 year.</td> </tr> <tr> <td>Replacement year</td> <td>Hardware – 2019, Painting – 2018.</td> </tr> </table>	Installation date	1941	Life expectancy	Doors (60), hardware (35), painting (15) years.	Chronological age	Doors - 76, Hardware – 57, Painting – 17 years.	Effective Age	Doors - 30, Hardware – 33, Painting – 14 years.	Remaining life span	Doors - 30, Hardware – 2, Painting – 1 year.	Replacement year	Hardware – 2019, Painting – 2018.

Installation date	1941												
Life expectancy	Doors (60), hardware (35), painting (15) years.												
Chronological age	Doors - 76, Hardware – 57, Painting – 17 years.												
Effective Age	Doors - 30, Hardware – 33, Painting – 14 years.												
Remaining life span	Doors - 30, Hardware – 2, Painting – 1 year.												
Replacement year	Hardware – 2019, Painting – 2018.												
Unit Quantity	<table border="1"> <tr> <td>Doors hardware</td> <td>40 doors</td> </tr> <tr> <td>Paint doors and Trims</td> <td>60 doors</td> </tr> </table>	Doors hardware	40 doors	Paint doors and Trims	60 doors								
Doors hardware	40 doors												
Paint doors and Trims	60 doors												
Current repair/replacement cost	<p>Supply and install hardware - \$100 per door.</p> <p>Supply and install painting of doors and trims - \$50 per door.</p>												
Commentary	The actual doors are still performing satisfactorily. They are solid wooden doors so can potentially last the life of the building if maintained correctly. Painting of the doors and trims is required in the short term. Scuff marks and signs of deterioration of the finish were observed. The maintenance staff are most likely to undertake this work. Many of the doors hardware are not functioning. Handles and locks are broken. We recommend budgeting to replace a minimum of 40 doors hardware within the next two years.

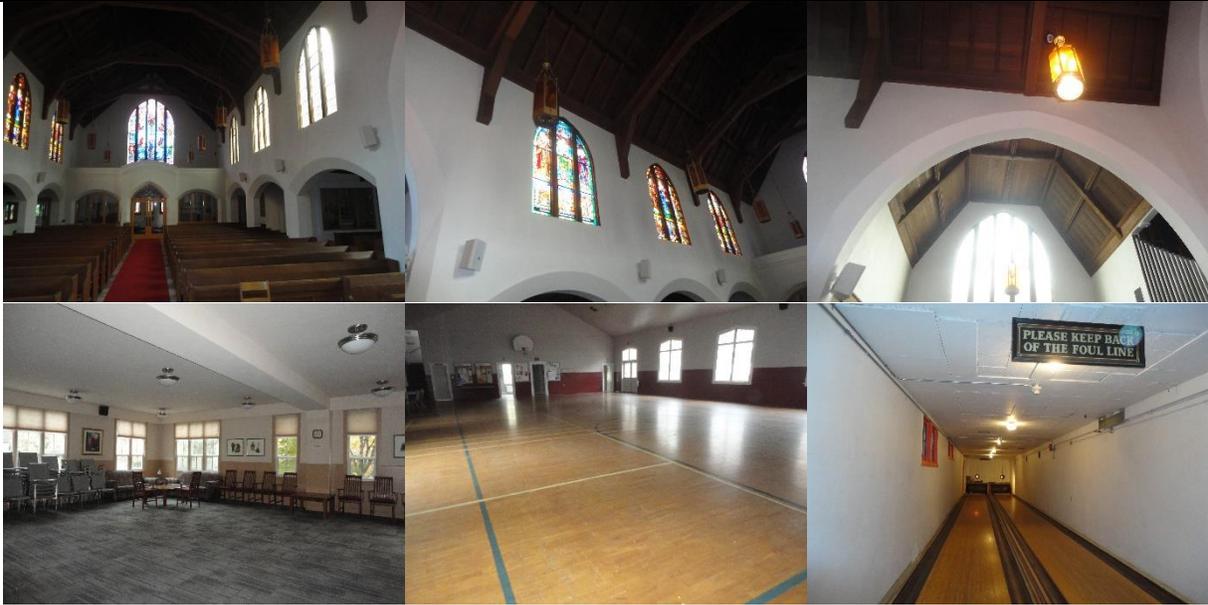
Component (9) Wall finishes		
Building Component	Painted wall finish to drywall and wood panels	
Description	The walls are painted in vinyl matt paint finish	
Overall Condition	Various	
Life Cycle Analysis	Installation date Life expectancy Chronological age Effective Age Remaining life span Replacement year	Various 15 – 20 years depending on usage Various years Various years Various years Church – 2019
Unit Quantity	Church Main Hall – walls & ceilings Fireside room & kitchen Pre-school 1 & 2 Totem room & washrooms	Approximately 10,000 sf Approximately 10,000 sf 2,500 sf 3,500 sf 1,400 sf
Current repair/replacement cost	\$0.80 per sf	
Commentary	The wall finishes are in various states of condition. The church requires painting in the short term as it is showing signs of deterioration. Also, the main hall should be considered for repainting soon. All other areas have been budgeted for at varying dates. Painting in this building is required on a regular basis.

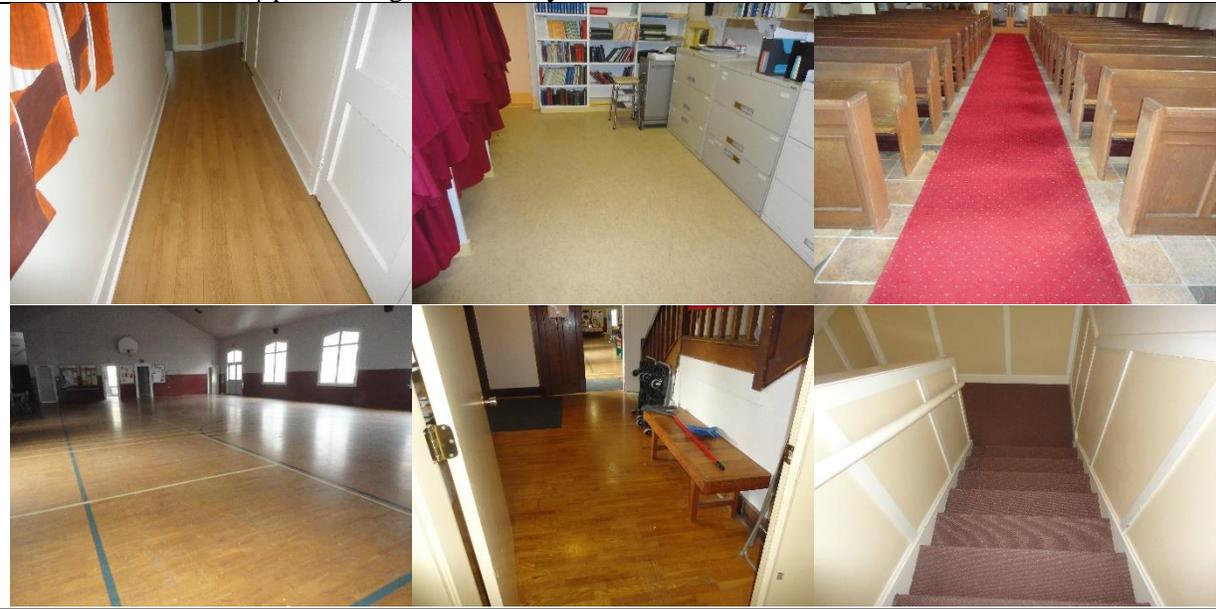
Component (10) Floor finishes													
Building Component	Carpet, vinyl, vinyl plank and slate floor finishes.												
Description	The church consists of carpet and slate, the main hall consists of wooden flooring, the fireside room contain carpet, the kitchens have vinyl flooring and the remainder consists of vinyl, vinyl plank and carpet.												
Overall Condition													
Life Cycle Analysis	<table border="1"> <tr> <td>Installation date</td> <td>Various dates</td> </tr> <tr> <td>Life expectancy</td> <td>15 – 25 depending on usage</td> </tr> <tr> <td>Chronological age</td> <td>Various</td> </tr> <tr> <td>Effective Age</td> <td>Various</td> </tr> <tr> <td>Remaining life span</td> <td>Various</td> </tr> <tr> <td>Replacement year</td> <td>Church – 2024, Main hall – 2019, offices – 2019, fireside room - 2022, stairs – 2018 and kitchen main floor – 2020.</td> </tr> </table>	Installation date	Various dates	Life expectancy	15 – 25 depending on usage	Chronological age	Various	Effective Age	Various	Remaining life span	Various	Replacement year	Church – 2024, Main hall – 2019, offices – 2019, fireside room - 2022, stairs – 2018 and kitchen main floor – 2020.

Kitchen	200 sf												
Current replacement cost	<p>Carpet and vinyl flooring \$5.00 per sf</p> <p>Wooden floor (sand and stain) - \$3.50 per sf</p> <p>Carpet to church - \$10.00 per sf</p>												
Commentary	The floor finishes are in various condition. Slate flooring was added to the church in 2000. The main hall wooden flooring requires re-finishing (sanding and staining). The carpet in the church is performing satisfactorily. The carpet to the stairs (to caretaker’s suite and upper floor adjacent hall) is showing signs of deterioration and this should be considered for replacement in the short term. The carpets to the offices are also showing signs of deterioration and should be replaced in the short term. Other locations are performing satisfactorily.

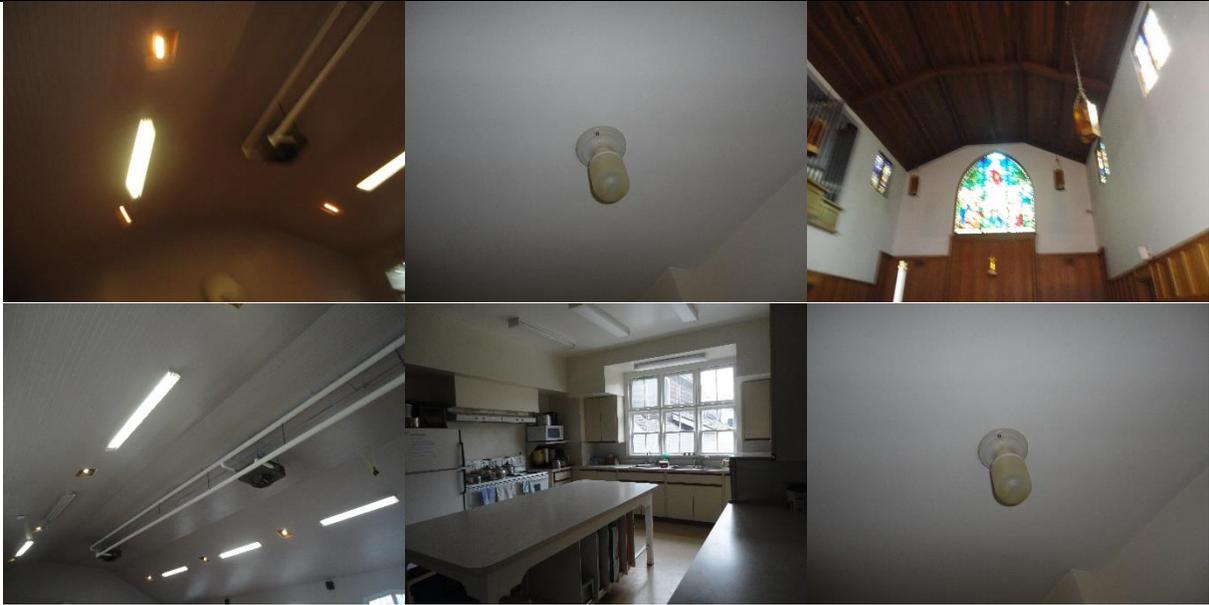
Component (11) Ceiling Finishes		
Building Component	Painted finish top drywall and wood panelling	
Description	The ceilings are painted in vinyl matt paint finish	
Overall Condition		
Life Cycle Analysis	Installation date Life expectancy Chronological age Effective Age Remaining life span Replacement year	Various 15 – 20 years depending on usage Various years Various years Various years Fireside room – 2023
Unit Quantity	Offices Church Daycare Fireside room & kitchen Totem and washroom	1,300 sf 4,500 sf 2,700 sf 1,900 sf 520 sf
Current repair/replacement cost	\$0.70 per sf (painting drywall) and \$3.00 per sf (staining wood in church)	
Commentary	The ceiling finishes are in various states of condition. The fireside requires painting in the short term as it is showing slight signs of deterioration. Also, the main hall should be considered for repainting in the short term.

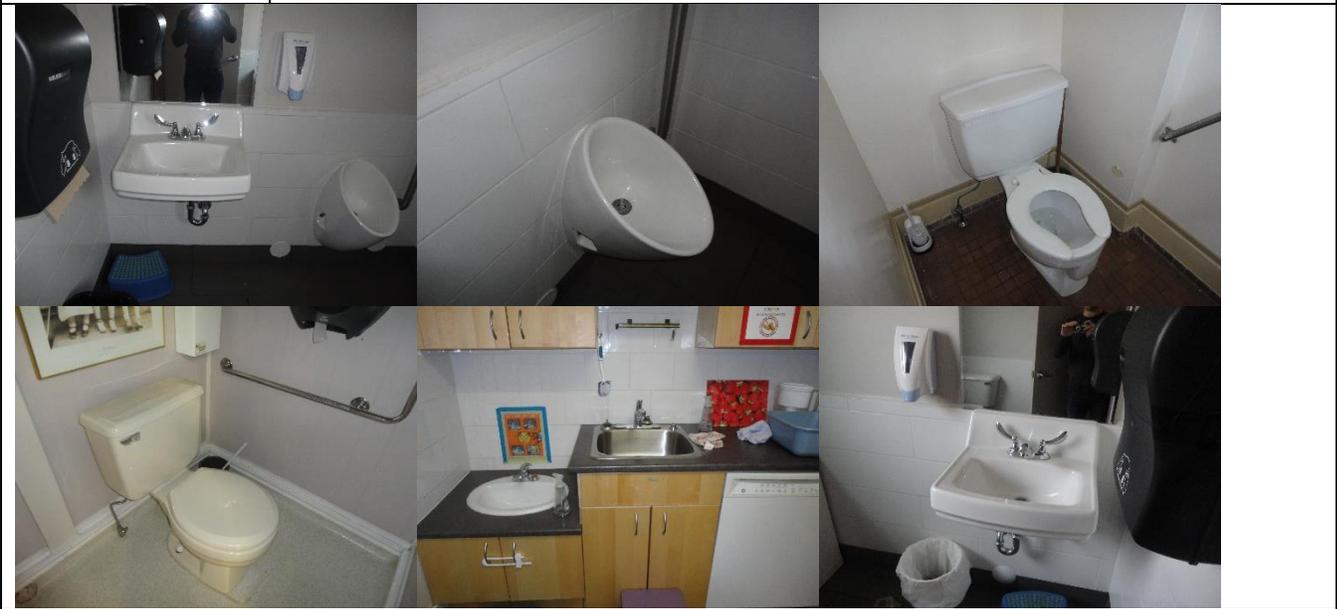
Component (12) Plumbing Fixtures													
Building Component	Ceramic toilets, Ceramic washroom sinks, ceramic urinals and stainless-steel kitchen sinks.												
Description	The washrooms and kitchens include ceramic toilets, ceramic washroom sinks, ceramic urinals and stainless-steel kitchen sinks & faucets to kitchens.												
Overall Condition	Fair & Good												
Life Cycle Analysis	<table border="1"> <tr> <td>Installation date</td> <td>1990, 1995, 2000, 2010</td> </tr> <tr> <td>Life expectancy</td> <td>30 years</td> </tr> <tr> <td>Chronological age</td> <td>27, 22, 17 & 7 years</td> </tr> <tr> <td>Effective Age</td> <td>27, 22, 17 & 7 years</td> </tr> <tr> <td>Remaining life span</td> <td>3, 8, 13 & 23 years</td> </tr> <tr> <td>Replacement year</td> <td>2020 (5%), 2025 (20%), 2030 (60%) & 2040 (15%)</td> </tr> </table>	Installation date	1990, 1995, 2000, 2010	Life expectancy	30 years	Chronological age	27, 22, 17 & 7 years	Effective Age	27, 22, 17 & 7 years	Remaining life span	3, 8, 13 & 23 years	Replacement year	2020 (5%), 2025 (20%), 2030 (60%) & 2040 (15%)

Commentary	The plumbing fixtures are performing satisfactorily. They have varying installation dates. We have allocated replacement of the fixtures periodically over the next thirty years. Replacement of faucets is expected to be required in the short term.

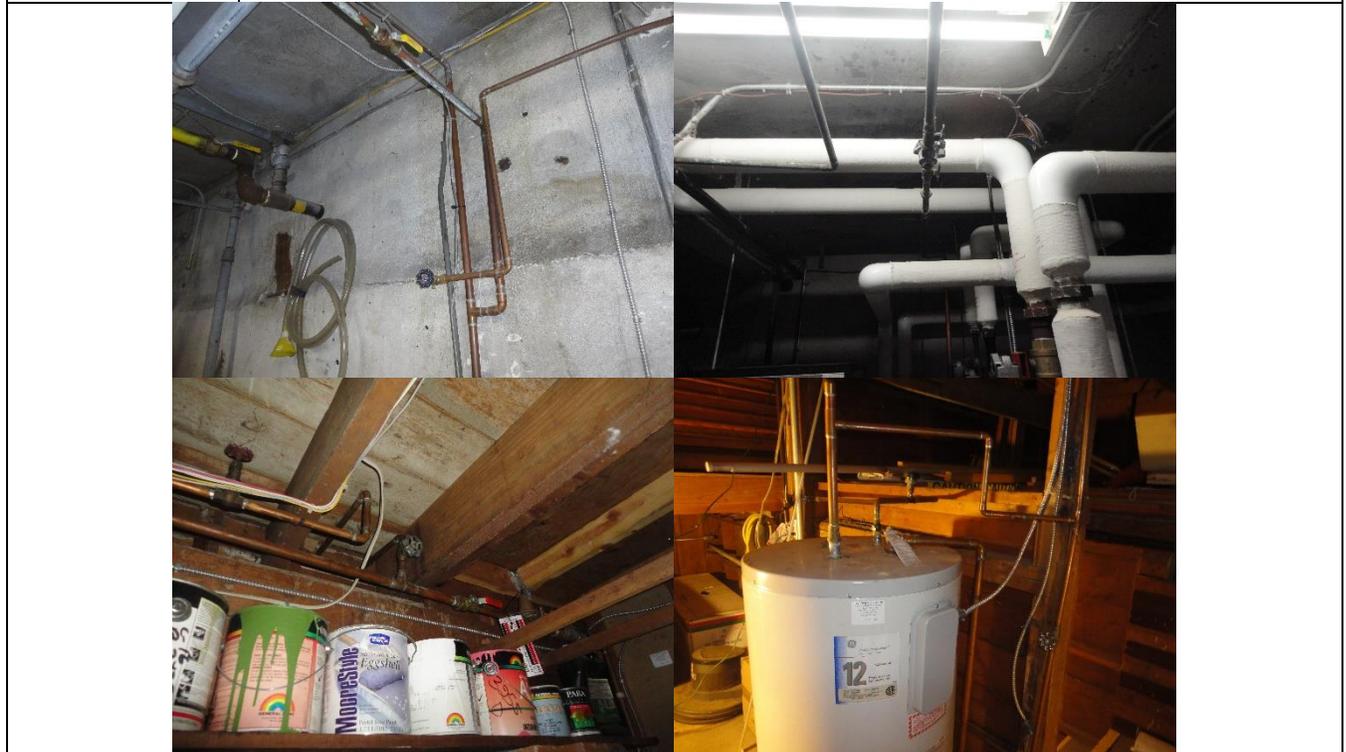
Component (13) Domestic water distribution													
Building Component	Copper distribution piping.												
Description	The domestic piping consists of copper hot and cold water lines. Some sections of pex piping have been installed.												
Overall Condition	Fair												
Life Cycle Analysis

Installation date	1941	Life expectancy	50 years	Chronological age	76 years	Effective Age	40 years	Remaining life span	10 years	Replacement year	2027
Installation date	1941												
Life expectancy	50 years												
Chronological age	76 years												
Effective Age	40 years												
Remaining life span	10 years												
Replacement year	2027												
Unit Quantity	7 washrooms and four kitchens.												
Current replacement cost	Remove piping and install Wirsbo piping, repair drywall & make good finishes - \$75,000												
Commentary	The copper piping is functioning without any major issue. It is old but has not had many leaks. Repairs have been completed in various locations at various dates. Sections of pex piping have been installed. Access to the piping is not difficult due to the crawl-space and basement. We recommend budgeting to replace all the piping with Wirsbo piping within approximately ten years. The drywall will require repairs in locations after installation. We recommend continued observation of the piping as it may last longer than the ten years predicted.

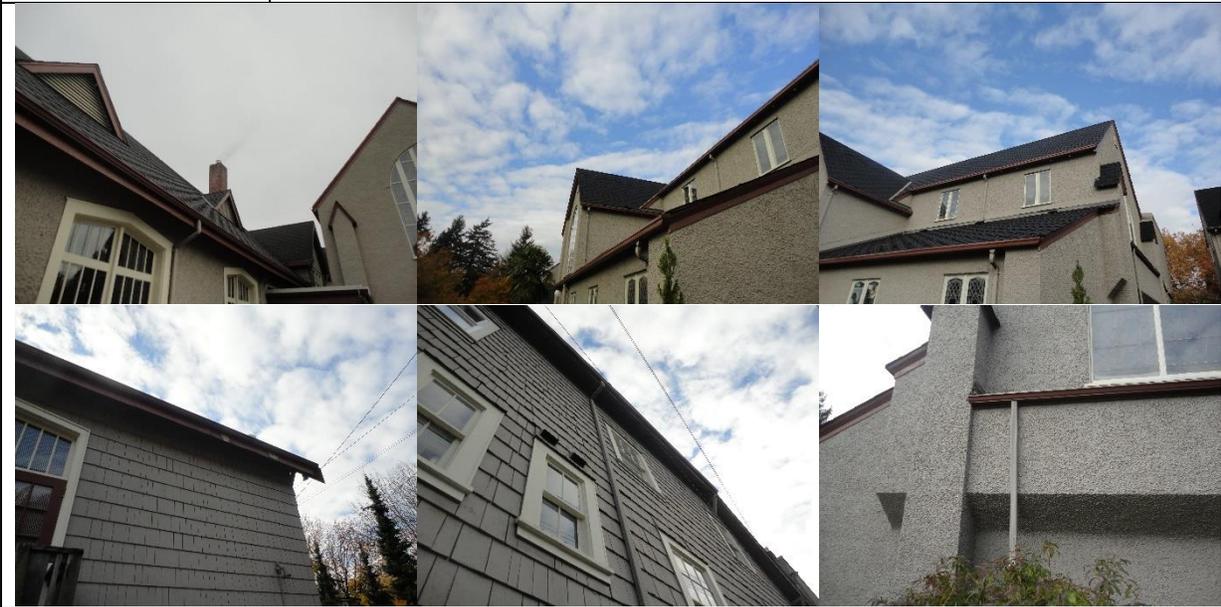
Component (14) Rainwater drainage system		
Building Component	Gutters and Downpipes	
Description	The rainwater drainage system consists of aluminum gutters and downpipes.	
Overall Condition	Good	
Life Cycle Analysis	Installation date	1999 – presumed
	Life expectancy	25 years
	Chronological age	18 years
	Effective Age	15 years
	Remaining life span	10 years
	Replacement year	2027
Unit Quantity		1 item
Current repair/replacement cost	Supply and install gutters and downpipes - \$10,000	
Commentary	The gutters and downpipes are functioning without any major issue. No major defects were observed or reported. Some small repairs are required to downpipes in locations. Any repairs can be considered under operations and maintenance. We recommend budgeting to replace the gutters and downpipes within ten years.

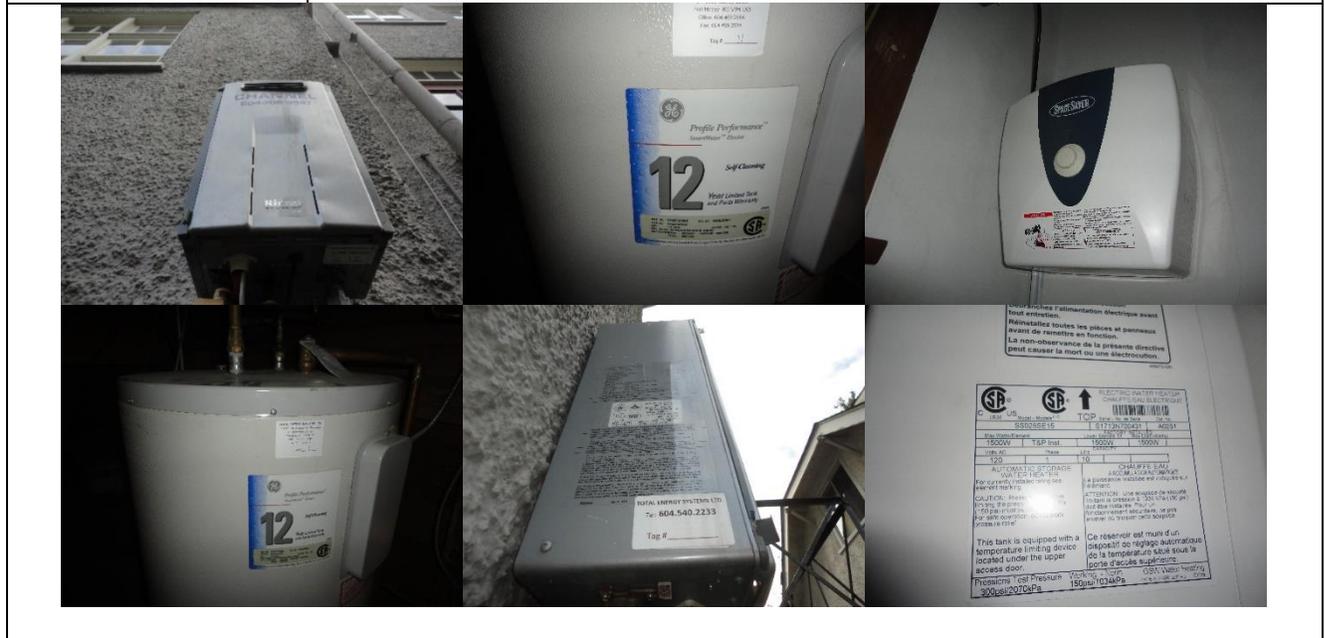
Component (15) Domestic Heaters													
Building Component	Domestic hot water heaters												
Description	The building contains three domestic hot water heaters - a Rinnai on-demand gas fired domestic hot water heater, model R75 RLSe hanging on the outside west wall, a General Electric electrical powered domestic hot water heater in the storage room and a Space domestic hot water heater in the washroom in the church.												
Overall Condition	Poor and Good												
Life Cycle Analysis	<table border="1"> <tr> <td>Installation date</td> <td>2013, 2006 & 2017</td> </tr> <tr> <td>Life expectancy</td> <td>15, 12 & 10 years</td> </tr> <tr> <td>Chronological age</td> <td>4, 11 & 0 years</td> </tr> <tr> <td>Effective Age</td> <td>4, 11 & 0 years</td> </tr> <tr> <td>Remaining life span</td> <td>11, 1 & 10 years</td> </tr> <tr> <td>Replacement year</td> <td>2028, 2018 & 2027</td> </tr> </table>	Installation date	2013, 2006 & 2017	Life expectancy	15, 12 & 10 years	Chronological age	4, 11 & 0 years	Effective Age	4, 11 & 0 years	Remaining life span	11, 1 & 10 years	Replacement year	2028, 2018 & 2027

Rinnai on demand heater	- \$4,500												
General Electric heater	- \$900												
Space domestic hot water	- \$600												
Commentary	The domestic hot water heaters are all functioning satisfactorily. The tankless system, located on the west side of the building (supplying the basement and main kitchen) was installed in 2013, the space heater was recently installed and is located in the church and the General electric heater is located in the basement (supplying the washrooms in the middle and the caretaker's suite). The General Electric heater is older and nearing design life expectancy. This is the next heater planned for replacement.

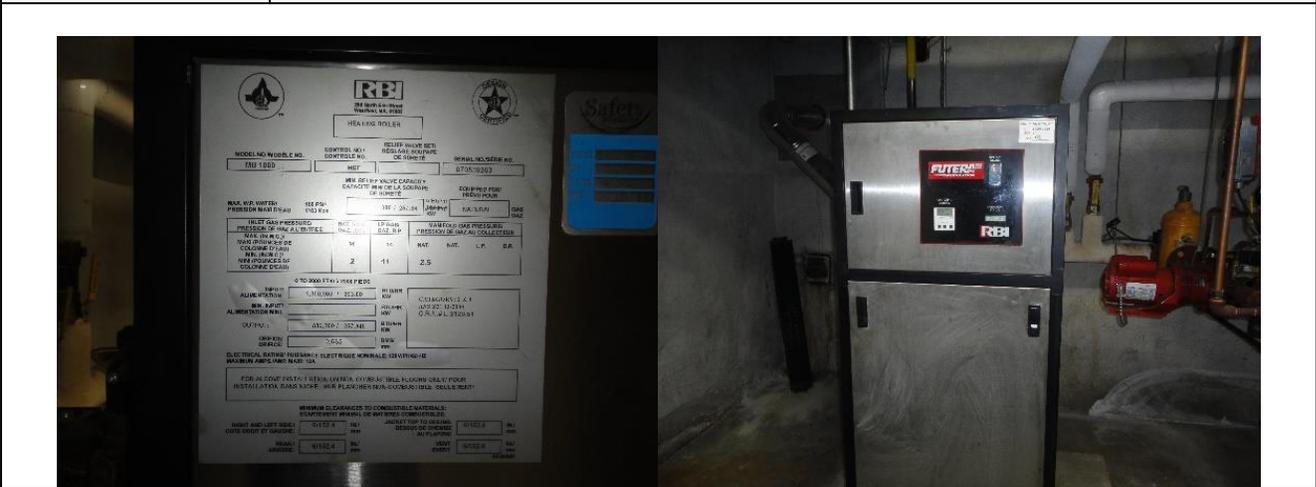
Component (16) Heating Boiler		
Building Component	Hot water hydronic heating boiler	
Description	The boiler is a Futera natural gas fired hot water hydronic heating boiler, model HW104437, with Tekmar controls.	
Overall Condition	Good	
Life Cycle Analysis	Installation date	2005
	Life expectancy	22 years
	Chronological age	12 years
	Effective Age	12 years
	Remaining life span	10 years
	Replacement year	2027
Unit Quantity		1 item
Current repair/replacement cost	Supply and install boiler, control valves, thermostats etc. - \$25,000	
Commentary	<p>The gas fired hydronic boiler is located in the mechanical room in the basement under the main hall. The boiler provides hot water heating to all areas of the building. The boiler has an input of 1,000,000 BTU/hr and an output of 880,000 BTU/hr. This results in an 88% efficiency rate, making the boiler a mid-efficiency boiler. There are two circulation pumps (Taco and Bell and Gossett), located on the hydronic piping, which circulate the hot water throughout the hydronic distribution piping loops. One hydronic loop travels to the office, pre-schools and fireside room and the heat is released here through convectors. Another loop travels to the main gym hall. This area contains Modine fan heaters hanging from the ceiling and the heat is transferred to hot air in this area. Another loop travels to the church and this area is heated by a forced air system. The heat from the hydronic piping is transferred through a make-up air unit/heat exchanger in the second mechanical room on the east side of the building. The boiler is controlled by Tekmar controls, which regulate the temperature of the hydronic water based on outside temperatures. The boiler is functioning without any major issue and has another expected sixteen years of life remaining. Annual servicing and cleaning is recommended. This can be considered under operations and maintenance.</p>

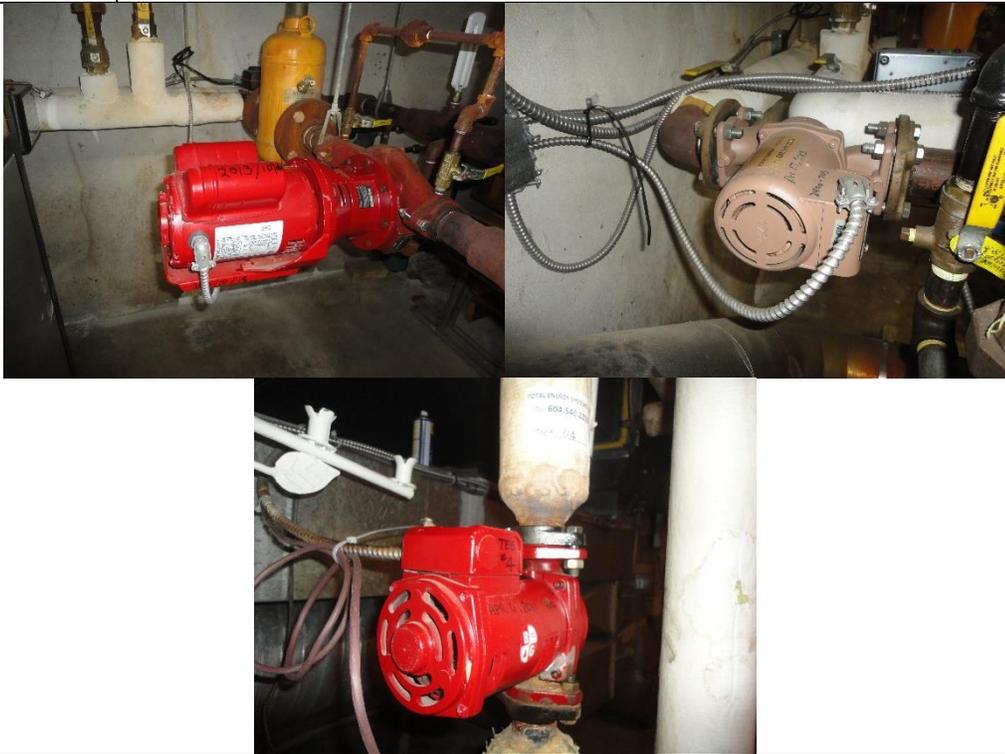
Component (17) Primary HVAC Pumps													
Building Component	Hydronic circulating pumps – 3.												
Description	Taco & Bell and Gossett circulating pumps												
Overall Condition	Fair												
Life Cycle Analysis

Installation date	2011 & 2013	Life expectancy	10 & 7 years	Chronological age	4 & 6 years	Effective Age	4 & 5 years	Remaining life span	6 & 2 years	Replacement year	2023 & 2019
Installation date	2011 & 2013												
Life expectancy	10 & 7 years												
Chronological age	4 & 6 years												
Effective Age	4 & 5 years												
Remaining life span	6 & 2 years												
Replacement year	2023 & 2019												
Unit Quantity	3 items												
Current repair/replacement cost	Supply and install pump - \$400 per pump Supply and install pump - \$600 per pump												
Commentary	<p>Two of the circulating pumps are located on the hydronic piping in the main mechanical room. The other pump is located on the hydronic loop in the secondary mechanical room, which contains the Carrier make-up air unit/heat exchanger. The first two pumps circulate the hot water in the hydronic piping throughout the building. The third pump circulates the water through the make-up air unit, which transfers heating to the forced air system. No major defects were observed or reported. The pumps may not need to be fully replaced. They can be repaired in parts. We recommend making an allowance of \$400 for each pump every seven years in the main mechanical room and \$600 to fully replace the other pump.</p>

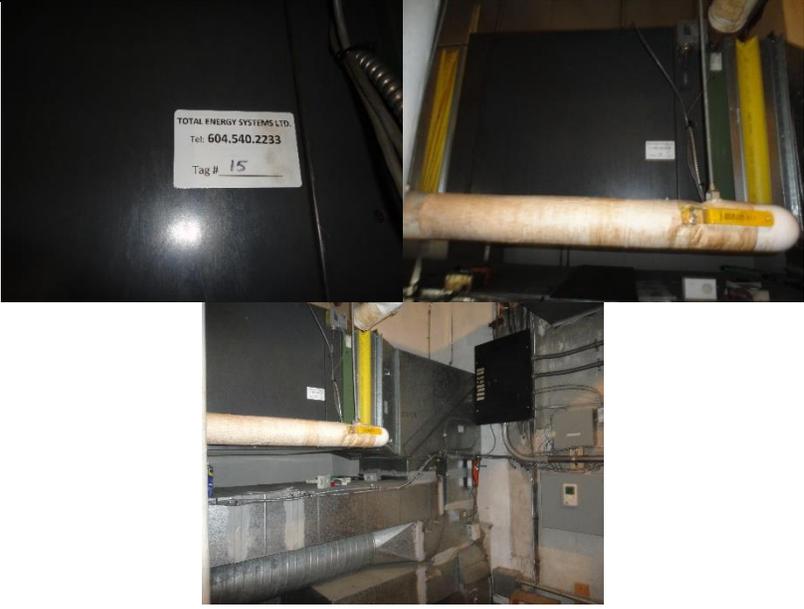
Component (18) Heat Exchanger		
Building Component	Heat exchanger/make-up air unit	
Description	Carrier Heat exchanger/make-up air unit	
Overall Condition	Good	
Life Cycle Analysis	Installation date	2013
	Life expectancy	30 years
	Chronological age	4 years
	Effective Age	4 years
	Remaining life span	26 years
	Replacement year	2043
Unit Quantity		1 item
Current repair/replacement cost	Supply and install Make-up air unit - \$35,000	
Commentary	The heat exchanger is a new addition to the building. It was added in 2015 by Total Energy Systems LTD. It transfers the heating from the hydronic water piping to the forced air system, which is then distributed through aluminum ducting throughout the church building. No major defects were observed or reported with the make-up air unit/heat exchanger. Annual servicing is required.

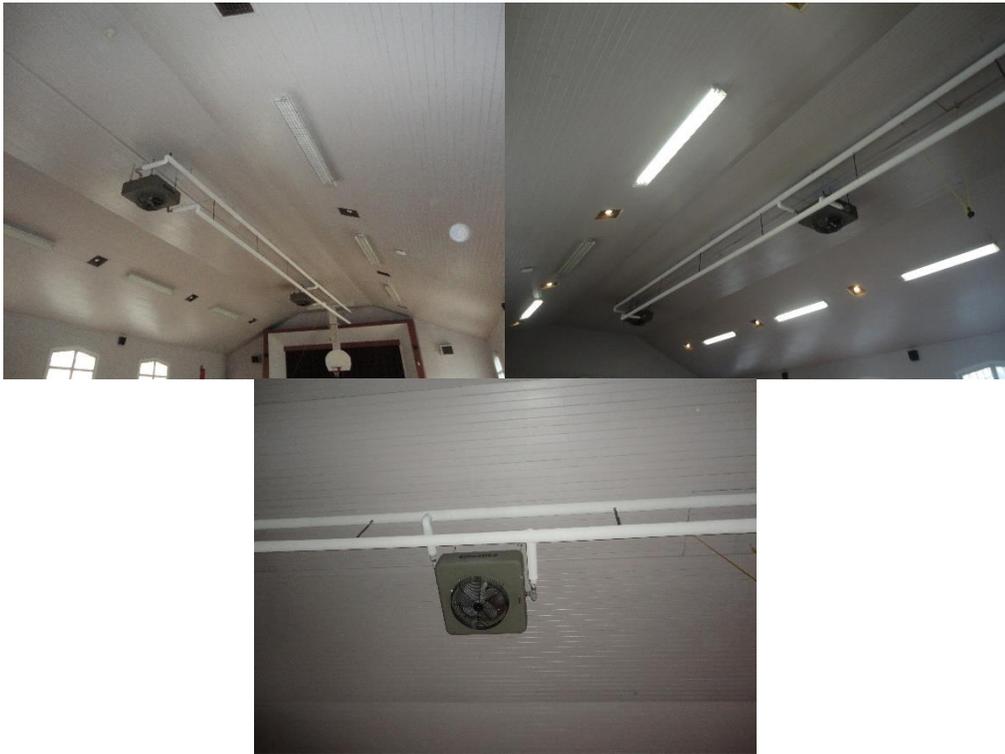
Component (19) Unit heaters		
Building Component	Ceiling fan heaters	
Description	Modine electrical powered ceiling mounted fan heaters	
Overall Condition	Good	
Life Cycle Analysis	Installation date	1990 – assumed
	Life expectancy	30 years
	Chronological age	27 years
	Effective Age	20 years
	Remaining life span	10 years
	Replacement year	2027
Unit Quantity		2 items
Current repair/replacement cost	Supply and install unit heaters - \$5,000 per unit	
Commentary	The unit heaters are functioning without any issue. They may require some small repairs. This can be considered under operations and maintenance. We recommend budgeting to fully replace the heaters within ten years.
