***ST. PHILIPS ANGLICAN CHURCH
BUILDING CONDITION ASSESSMENT
& CAPITAL PLAN***

**Presented to:
The Board
St Philips Anglican Church**

November 29, 2017

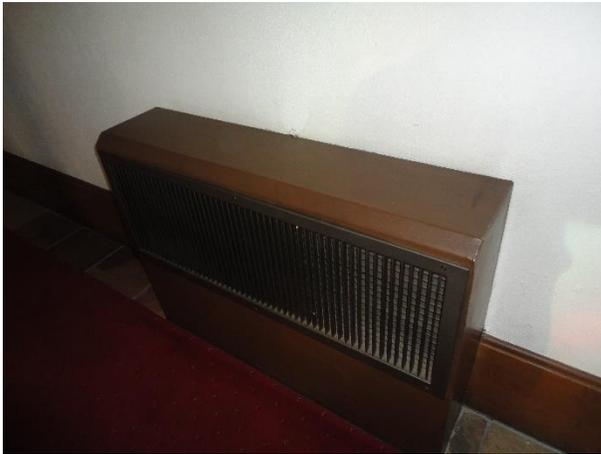
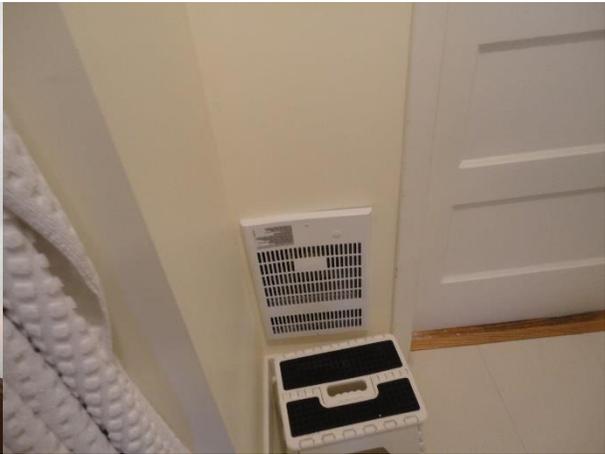
Component (20) Unit Heaters		
Building Component	Unit fan heaters	
Description	The church contains four fan heaters on the side walls and the caretaker's unit contains one electrical fan heater in the washroom.	
Overall Condition	Good and Poor	
Life Cycle Analysis	Installation date	1980 & 2000
	Life expectancy	35 & 25 years
	Chronological age	37 & 17 years
	Effective Age	27 & 24 years
	Remaining life span	10 & 1 year
	Replacement year	2027 & 2018
Unit Quantity	Church heaters	4 ea
	Caretakers suite	1 ea
Current repair/replacement cost	Church heaters - \$1,500 – supply and install Caretakers suite - \$300 - supply and install	
Commentary	The heaters in the church are functioning without any issue. They obtain their heat from the Carrier make-up air unit in the mechanical room. The electrical powered fan heater in the caretaker's unit is not functioning properly. It was reported to be completely ineffective as the washroom is too cold. We recommend budgeting to upgrade this heater in the short term.

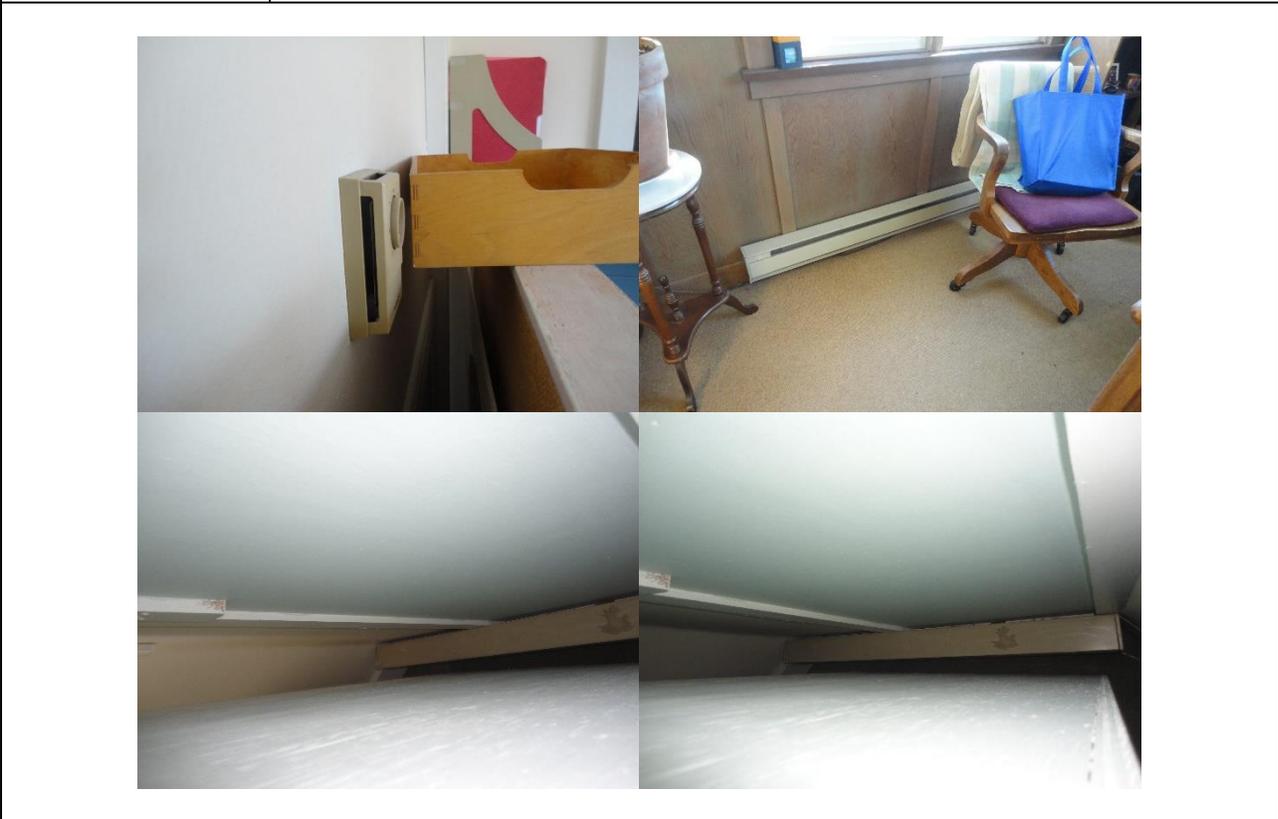
Component (21) Electrical Baseboard Heaters		
Building Component	Electrical baseboard heaters	
Description	A number of locations in the building contain aluminum electrical baseboards and Honeywell thermostats.	
Overall Condition	Good	
Life Cycle Analysis	Installation date	1990
	Life expectancy	35 years
	Chronological age	27 years
	Effective Age	27 years
	Remaining life span	8 years
	Replacement year	2025
Unit Quantity	Electrical baseboards and thermostats	3 items
Current repair/replacement cost	Supply and install baseboards and thermostats - \$350 per baseboard.	
Commentary	No major defects were observed or reported with the baseboards. They are functioning satisfactorily. They are a secondary source of heat for the office upstairs. They are not used regularly.

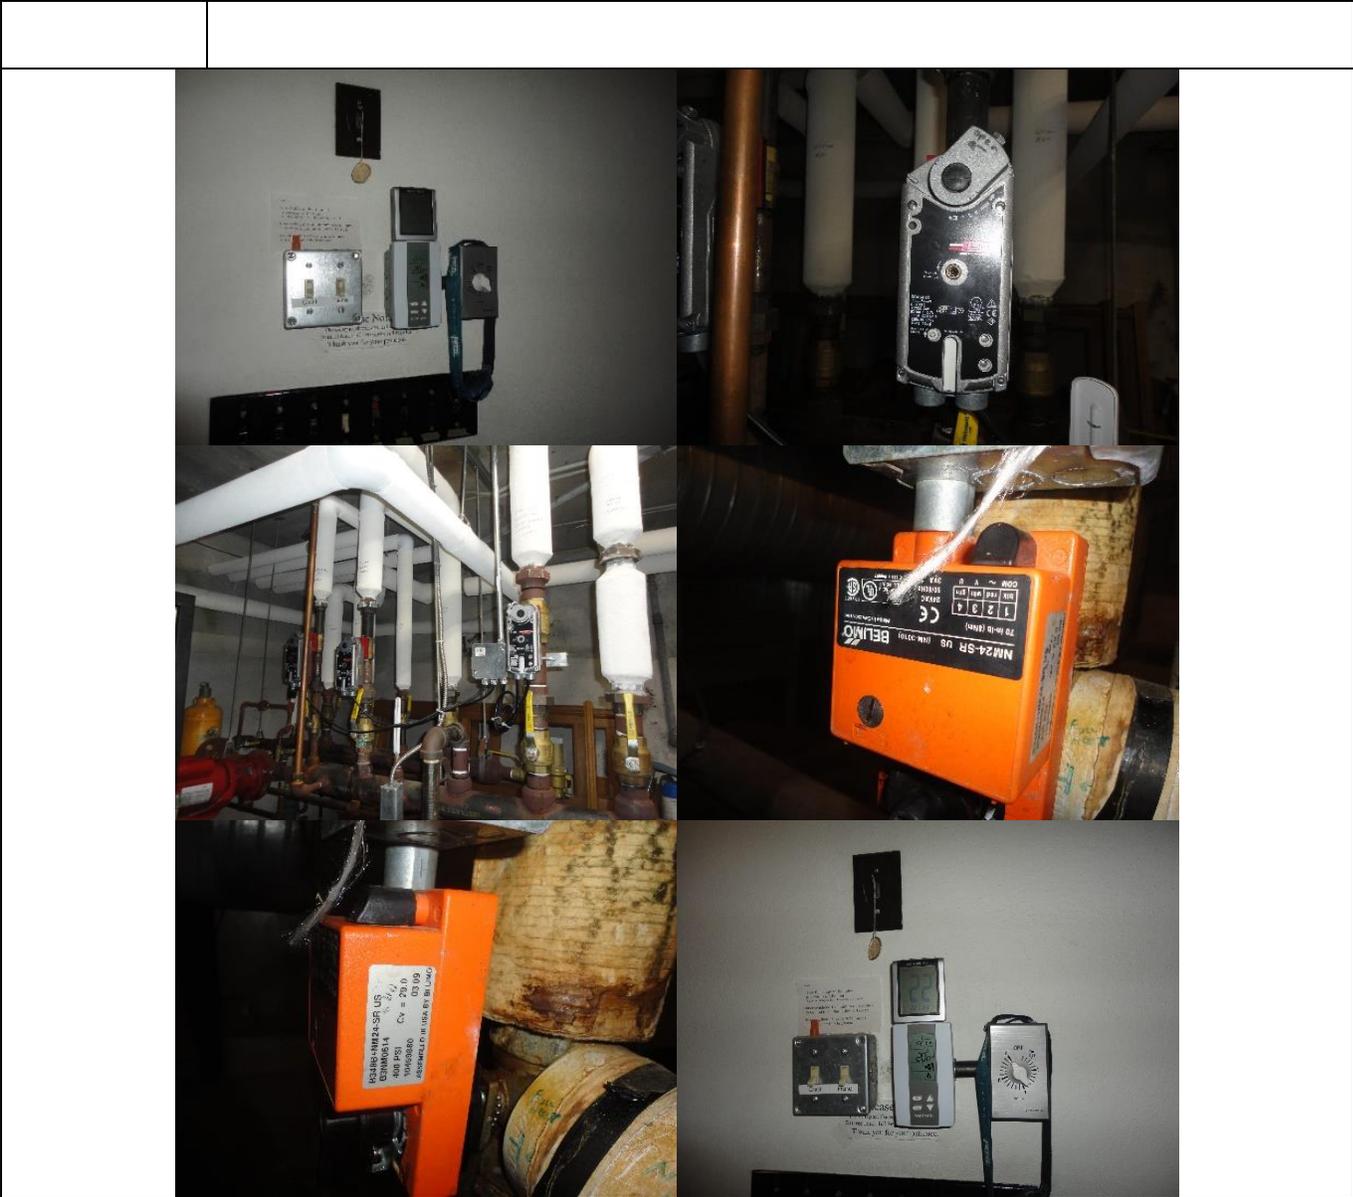
Component (22) Controls and Instrumentation		
Building Component	Thermostat controls and control valves for heating system	
Description	Forced air heating control - Neptronic thermostat control for church (1). Controls for hydronic piping – Delta control valves (3). Convactor/radiator controls – Danfoss style valves (9) – to be installed. Pre-school control for sink – tempering mixing valve (1) – to be installed. HVAC system – Belimo motor valves (1).	
Condition	Good	
Life Cycle Analysis	Installation date	2017, 2013, 2018, 2018 & 2011.
	Life expectancy	25, 8, 25, 25 & 5 years.
	Chronological age	0, 4, 0, 0 & 6 years.
	Effective Age	0, 4, 0, 0 & 3 years.
	Remaining life span	25, 4, 25, 25 & 2 years.
	Replacement year	2042, 2021, 2018, 2018 & 2019.
Unit Quantity		Noted in description
Current replacement cost	Neptronic thermostat - \$1,000 Delta control valves - \$700 Dan Foss style - \$700 Tempering valve - \$1,000 Belimo motor valve - \$1,000

Commentary	<p>The Neptronic controls were recently installed to control the forced air temperature in the church. The temperature is required to be maintained constant in order to protect the organ from detuning. These controls operate the make-up air unit/heat exchanger in the adjacent mechanical room. They are new and functioning satisfactorily.</p> <p>The Delta control valves are located on three of the hydronic hot water heating loops exiting from the heating boiler. They control the hot water introduced to the heating loops in the gym, totem room and caretaker’s suite. They were recently replaced and are functioning satisfactorily. They require replacing approximately every eight years. The other heating loops do not have these controls.</p> <p>The nine convectors in the offices on the top floor currently have no controls and temperature in this location is far too hot on occasion. The introduction of Danfoss style valves to the convectors will enable temperature control in these areas. The mechanical company have also recommended this approach. As it is a single loop older system, replacing the piping and modifying it would be too costly. This approach is considered the most cost-effective approach. It was reported on the day of the inspection that the water in the ceramic sink in Crown pre-school is far too hot for children and is a safety issue. The temperature is set in the adjacent pre-school and it is set at a high temperature for the use of the dishwasher. The introduction of a tempering valve under the ceramic sink in Crown Pre-school will make the water a safe temperature for the children’s use. The children’s sink in Tom Thumb pre-school already incorporates its own tempering valve.</p> <p>The Belimo motor valve in the HVAC (heat exchanger) room controls the temperature of the hydronic water introduced through the heating coil in the heat exchanger, which heats the air being introduced to the church. The motor valve is set based on the outside air temperature. It is currently functioning satisfactorily but has a short life span of five years.</p> <p>The Tekmar controls for the hydronic boiler can be replaced in conjunction with the boiler and this has been budgeted for in the boiler component. The other thermostats throughout the building (e.g. pre-school & gym) are low cost items and can be considered under operations and maintenance.</p>

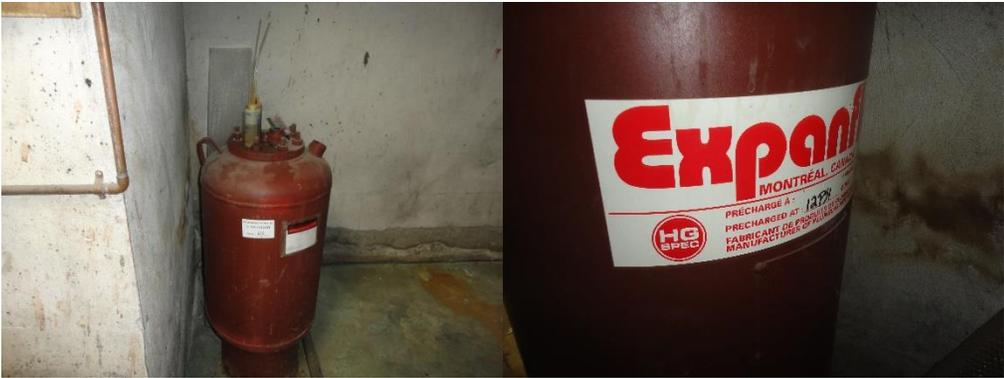
Component (23) Expansion Tank													
Building Component	Expansion tank for hydronic system												
Description	A.S.M.E. expansion tank												
Overall Condition													
Life Cycle Analysis

Installation date	2013	Life expectancy	35	Chronological age	4 years	Effective Age	4 years	Remaining life span	31 years	Replacement year	2048
Installation date	2013												
Life expectancy	35												
Chronological age	4 years												
Effective Age	4 years												
Remaining life span	31 years												
Replacement year	2048												
Unit Quantity	1 item												
Current repair/replacement cost	Supply and install expansion tank - \$3,500												
Commentary	No major defects were observed or reported. This expansion tank is a good quality tank. It has a bladder, and this can be replaced independently. We recommend budgeting to replace the tank at the end of design life expectancy.

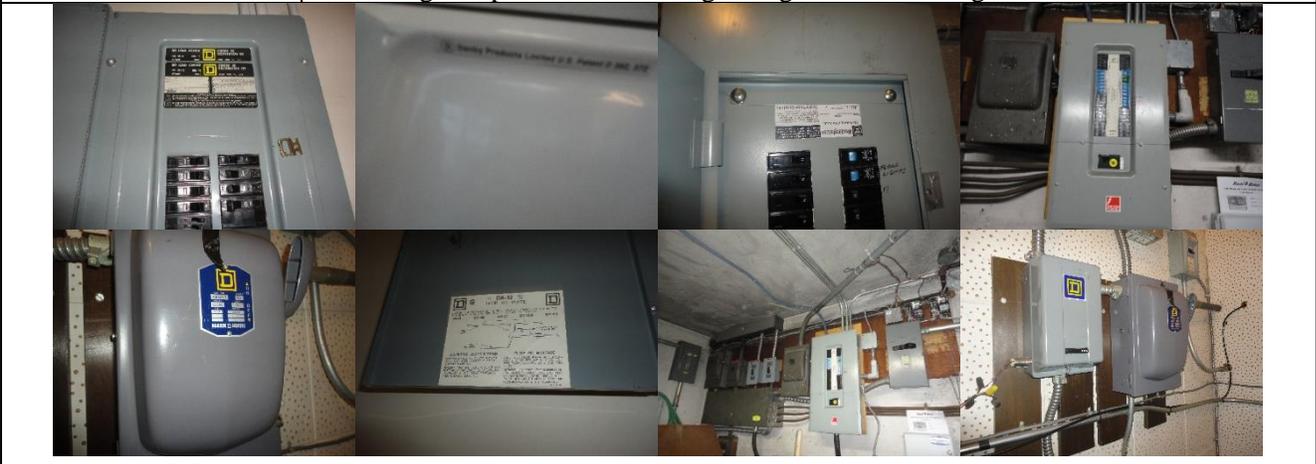
Component (24) Electrical Distribution		
Building Component	Electrical Breaker panels	
Description	The breaker panels in the building consist of 50-amp breaker panels, 60-amp breaker panels, 100-amp breaker panels, 150 amp breaker panels, 225 amp breaker panels and one 400 amp main breaker panel.	
Overall Condition	Poor, fair and good	
Life Cycle Analysis	Installation date	1941 & 2000
	Life expectancy	50 years
	Chronological age	76 and 17 years
	Effective Age	48, 72 & 17 years
	Remaining life span	2, 8 & 33 years
	Replacement year	2019 & 2025
Unit Quantity	Square D 100-amp breaker panel	1 item
	Federal Pioneer 125-amp breaker panel	1 item
	Square D 60-amp breaker panel	2 items
	Electrical MFG 100-amp breaker panel	2 items
	Square D 125-amp breaker panel	1 item
	Cutler Hammer 125-amp breaker panel	2 items
	Federal Electric panel 100-amp panel	1 item
	Federal Pioneer 125-amp breaker	1 item
	Main breaker - 400-amp panel	1 item

Westinghouse 50-amp breaker panel	1 item
	Westinghouse 225-amp breaker panel	1 item
Current repair/replacement cost	100-amp breaker panel - \$800 125- amp breaker panel - \$1,000 60-amp breaker panel - \$300 50-amp breaker panel - \$250 225-amp breaker panel - \$2,000 400-amp breaker panel - \$5,000	
Commentary	The majority of breaker panels are extremely old. They are believed to be the original, which were installed in 1941. Some breaker panels have been upgraded or added on. We recommend considering to budget for upgrading 50% of these panels in the short term as they have well exceeded design life expectancy. However, it must be noted that it was reported on site that the panels are not experiencing any issues. We further recommend budgeting for a detailed electrical investigation to the wiring and panels, considering the age of the building.

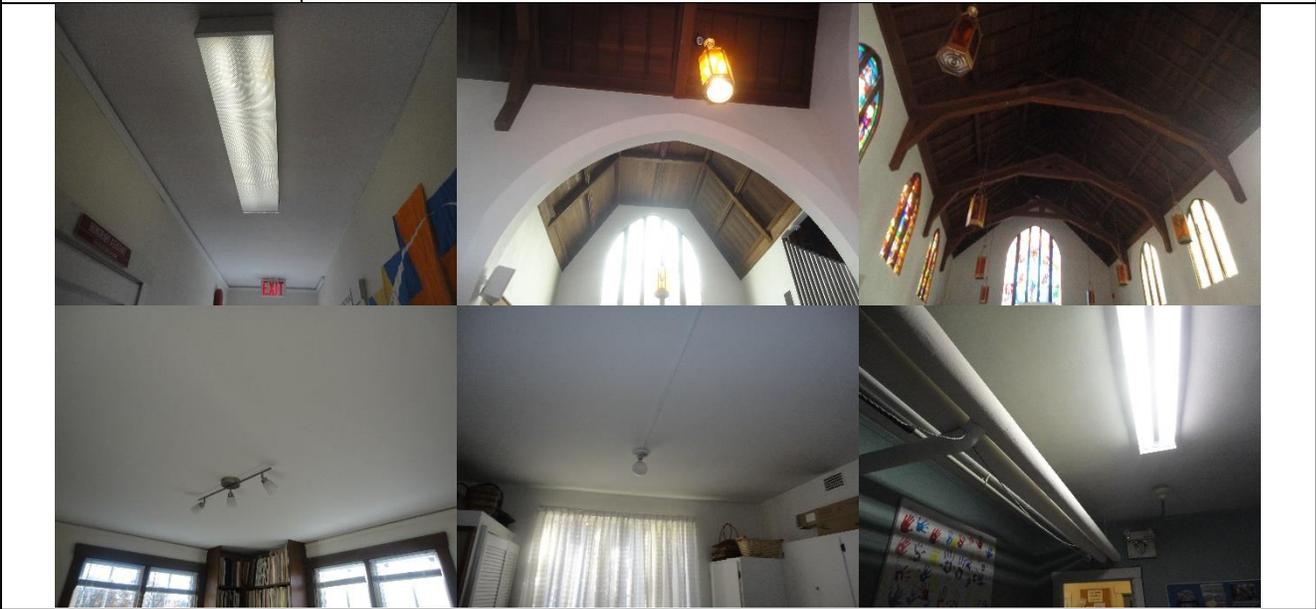
Component (25) Light Fixtures		
Building Component	Incandescent and Fluorescent light fixtures	
Description	The building has approximately 181 various types of light fixtures. They range from fluorescent tube lighting fixtures, incandescent light fixtures to hanging pendant lights in the church.	
Overall Condition	Various	
Life Cycle Analysis	Installation date Life expectancy Chronological age Effective Age Remaining life span Replacement year	Various – majority old 35 years Various Various 3 & 13 years 2020 & 2030
Unit Quantity	Church, main hall, caretaker’s suite, office, pre-school & fireside room etc.	181 fixtures
Current repair/replacement cost	10% of light fixtures - \$4,400 90 % of light fixtures - \$39,600	
Commentary	The light fixtures throughout the building are in various states of condition. Some are very old but functioning satisfactorily. Potentially all fixtures could be considered for upgrading in the short term for energy saving purposes. Also, it was reported that bulbs are becoming more difficult to procure for certain fixtures. However, we have concluded that this is not a viable option. We recommend budgeting to replace approximately 10% of the fixtures in the immediate short term. These are the fixtures that have obviously passed design life expectancy. All other fixtures should be monitored regularly.

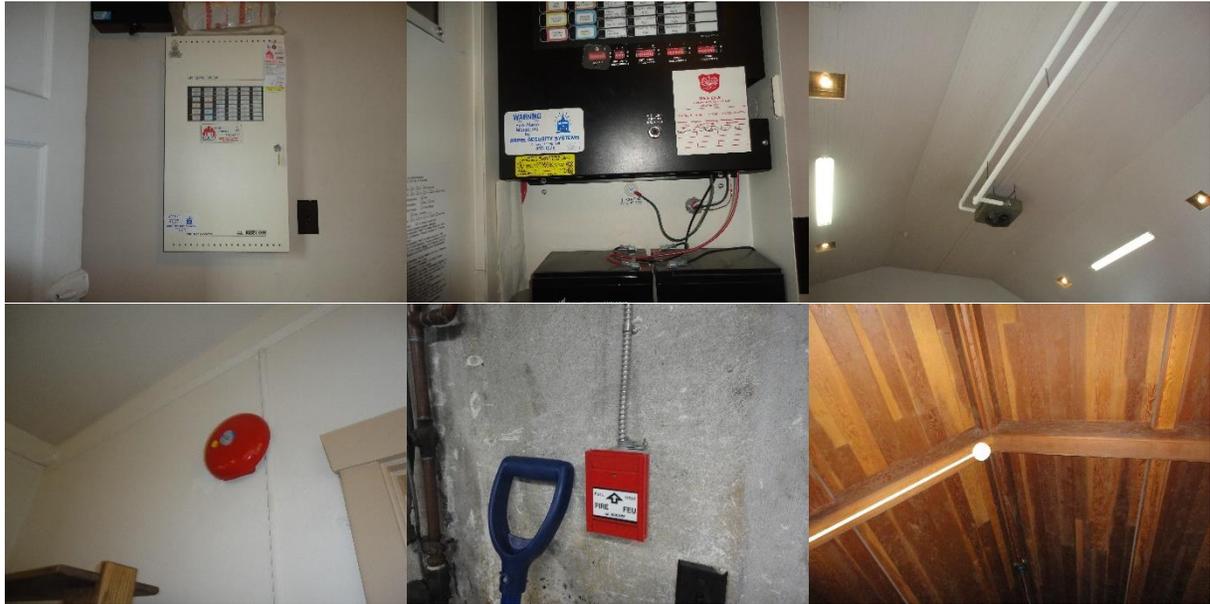
Component (26) Fire Alarm System		
Building Component	Fire Alarm System	
Description	The fire alarm system consists of a Mircom control panel, series 1000, heat detectors, bells and pull stations.	
Overall Condition	Good	
Life Cycle Analysis	Installation date	2001 - panel
	Life expectancy	25 years
	Chronological age	16 years
	Effective Age	16 years
	Remaining life span	9 years
	Replacement year	2026
Unit Quantity	Fire alarm panel	1 item
Current repair/replacement cost	Fire alarm panel - \$5,000 Heat detectors - \$300 each Bells - \$400 each	
Commentary	The fire alarm system is functioning without issue. The panel was replaced around 2001. No major defects were observed or reported. Any repairs can be considered under operations and maintenance. These panel typically have a twenty five year life span.

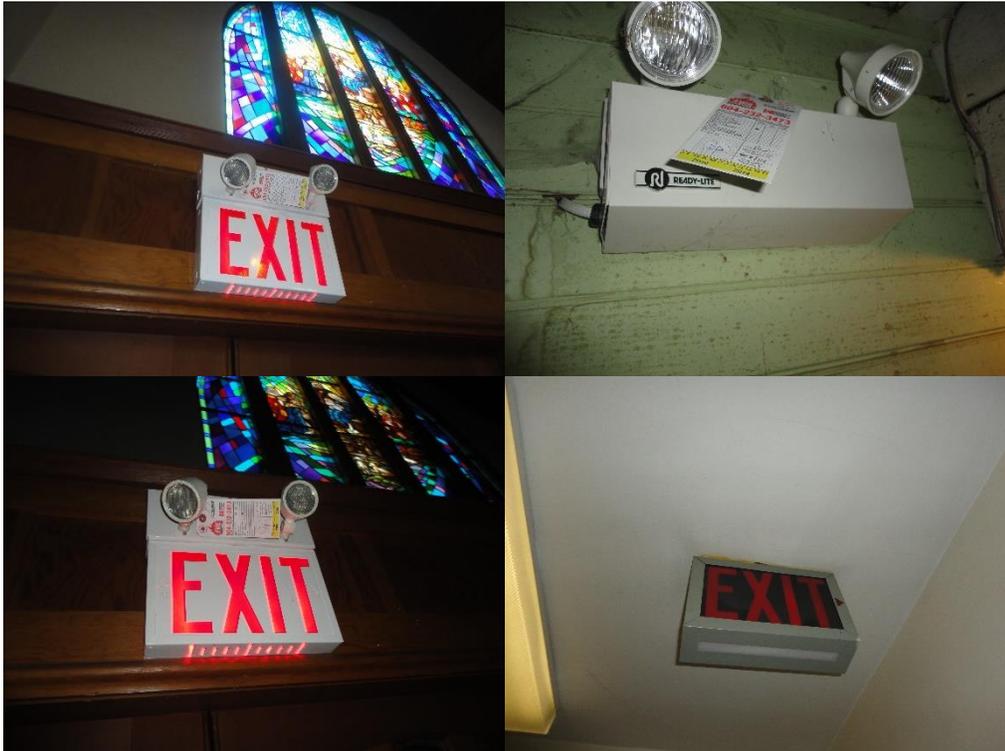
Component (27) Exit and Emergency Light Fixtures		
Building Component	Exit and Emergency Light Fixtures	
Description	The entrances to the building have exit and emergency light fixtures.	
Overall Condition	Poor and Good	
Life Cycle Analysis	Installation date	1960 & 2000 - assumed
	Life expectancy	30 years
	Chronological age	57 & 17 years
	Effective Age	28 & 17 years
	Remaining life span	2 & 13 years
	Replacement year	2019 & 2030
Unit Quantity	Old fixtures	4 ea
	Newer fixtures	10 ea
Current repair/replacement cost	Old fixtures - \$800 New fixtures - \$2,000	
Commentary	A number of the exit and emergency light fixtures are very old and should be replaced in the short term. The other fixtures were replaced and are in good condition.

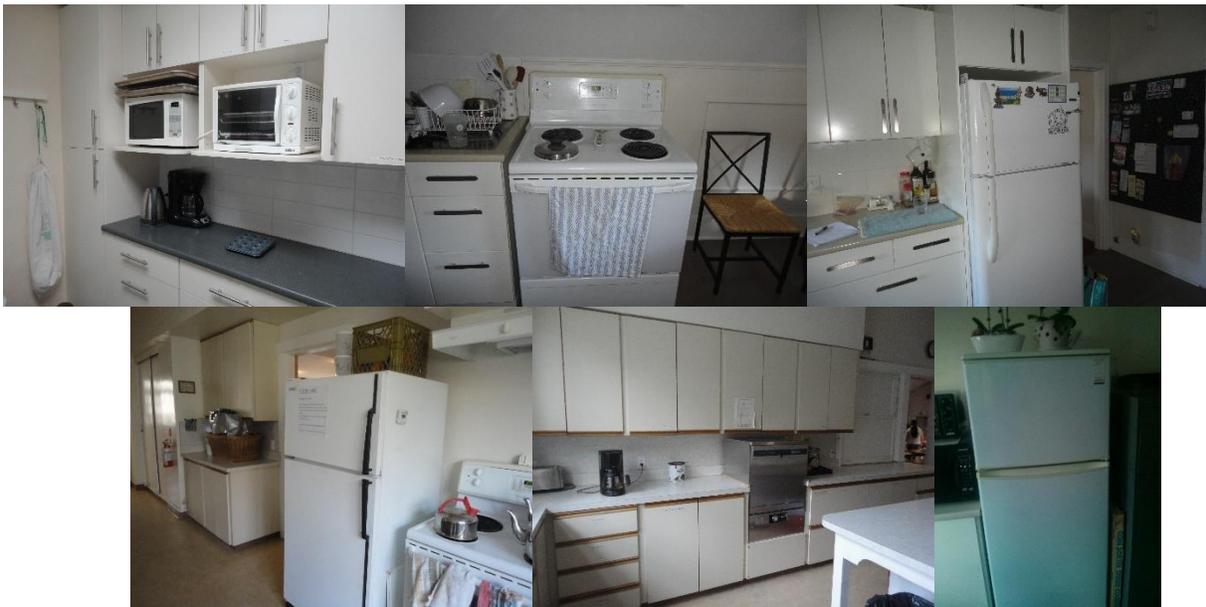
Reserve Component (28) Residential Appliances													
Reserve Component	Kitchen Appliances												
Description	The appliances consist of fridge/freezers, ovens, hood fans, dishwashers, washers, dryers etc.												
Overall Condition	Poor, fair & Good												
Life Cycle Analysis	<table border="1"> <tr> <td>Installation date</td> <td>Various</td> </tr> <tr> <td>Life expectancy</td> <td>8 – 15 years</td> </tr> <tr> <td>Chronological age</td> <td>Various</td> </tr> <tr> <td>Effective Age</td> <td>Various</td> </tr> <tr> <td>Remaining life span</td> <td>Various</td> </tr> <tr> <td>Replacement year</td> <td>Various</td> </tr> </table>	Installation date	Various	Life expectancy	8 – 15 years	Chronological age	Various	Effective Age	Various	Remaining life span	Various	Replacement year	Various
Installation date	Various												
Life expectancy	8 – 15 years												
Chronological age	Various

Pre-school Tom Thumbs	Dishwasher, fridge, microwave and toaster oven.												
Preschool – Crown	Fridge, microwave & dishwasher.												
Laundry room	Combined washer and dryer.												
Current repair/replacement cost	Total for all appliances - \$13,600												
Commentary	The appliances are in a wide variety of condition. They are being replaced as needed. The dishwasher in the main kitchen is particularly old and should be budgeted for replacement in the short term. The fridge in the main kitchen is also nearing design life expectancy. It may be possible to extend the life of some these appliances with repairs. For the purpose of capital planning, we have allowed for full replacement.

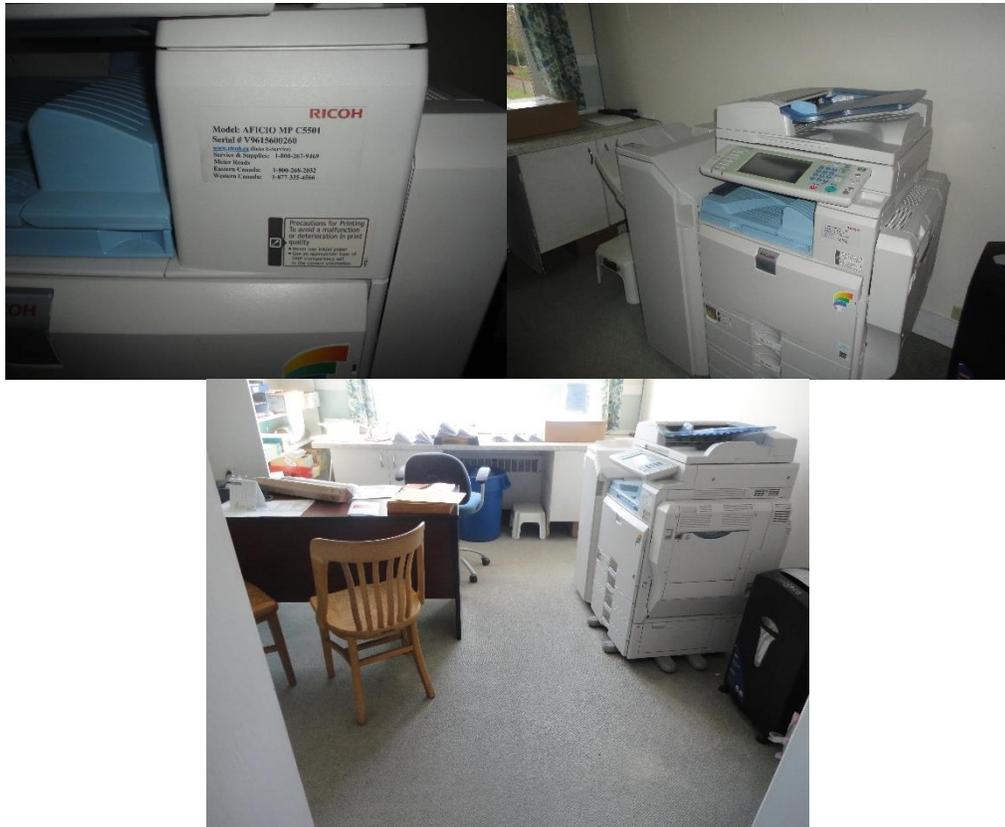
Component (29) Equipment													
Building Component	Photo copying machine												
Description	Ricoh office copier												
Overall Condition	Good												
Life Cycle Analysis

Installation date	2012	Life expectancy	15 years	Chronological age	5 years	Effective Age	5 years	Remaining life span	10 years	Replacement year	2027
Installation date	2012												
Life expectancy	15 years												
Chronological age	5 years												
Effective Age	5 years												
Remaining life span	10 years												
Replacement year	2027												
Unit Quantity	1 item												
Current repair/replacement cost	Supply and install - \$23,000												
Commentary	No major defects were observed or reported. The copier was reported to be functioning without any major issue.

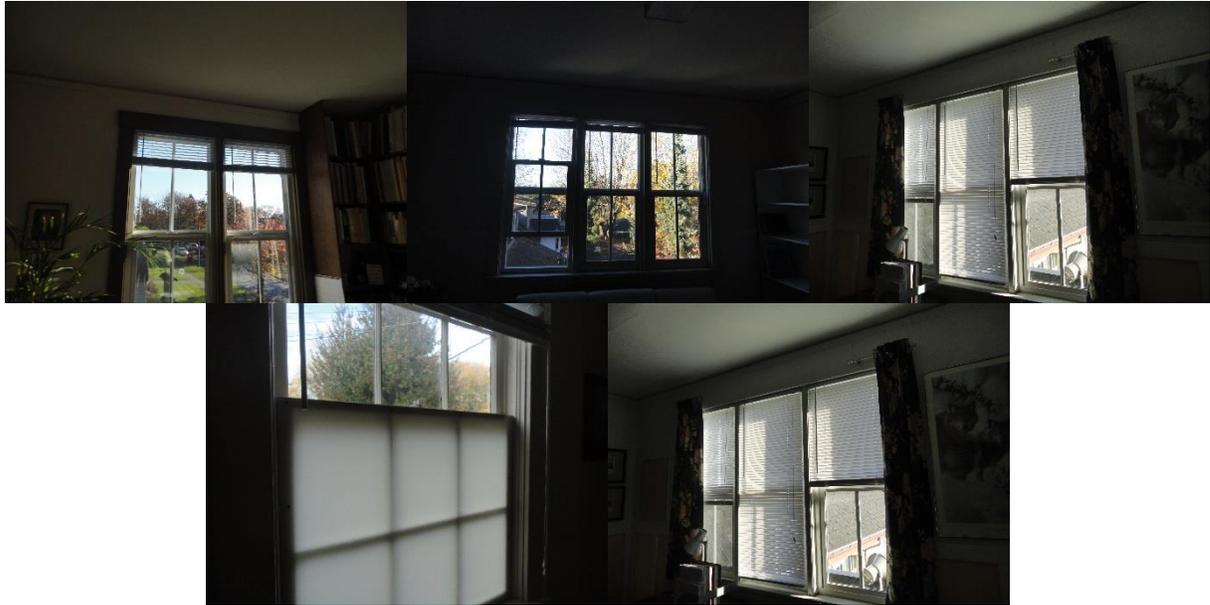
Component (30) Furnishing													
Building Component	Window blinds												
Description	The windows have blinds in some of the windows. The church and hall have none.												
Overall Condition	Good												
Life Cycle Analysis

Installation date	2005	Life expectancy	20 years	Chronological age	12 years	Effective Age	12 years	Remaining life span	8 years	Replacement year	2025
Installation date	2005												
Life expectancy	20 years												
Chronological age	12 years												
Effective Age	12 years												
Remaining life span	8 years												
Replacement year	2025												
Unit Quantity	40 ea												
Current repair/replacement cost	Supply and install blinds - \$100 per blind												
Commentary	No major defects were observed or reported. These blinds do not get much use. They are functioning without issue.

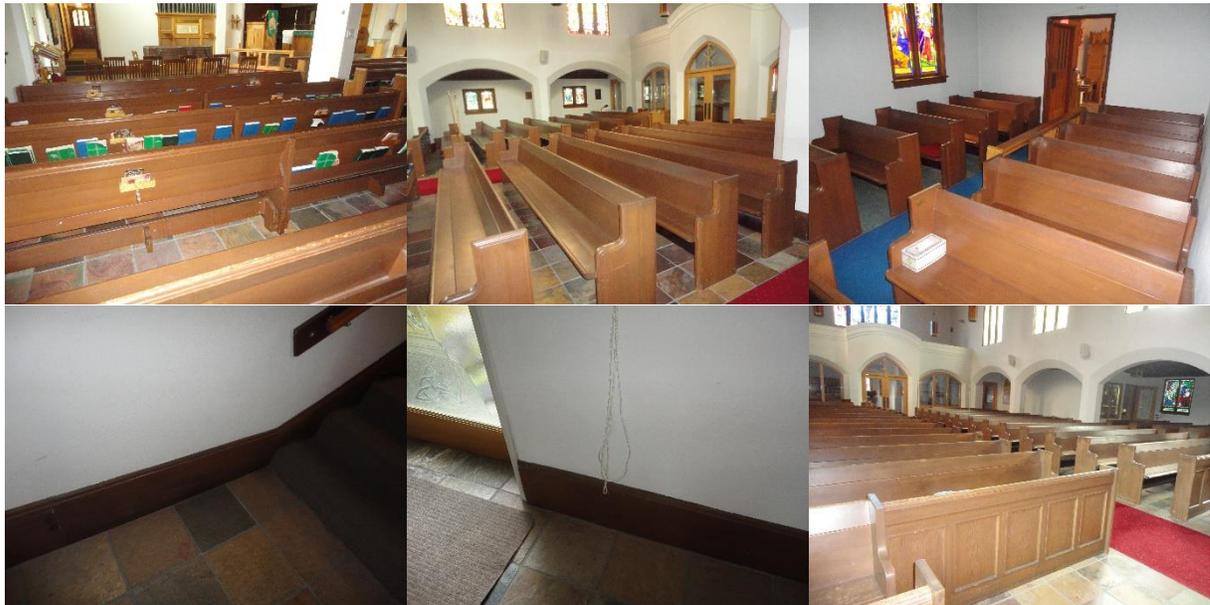
Component (31) Furniture		
Building Component	Wooden furniture	
Description	Sand, strip and paint finish to wooden pews and trims	
Overall Condition	Poor	
Life Cycle Analysis	Installation date	1980
	Life expectancy	25 years
	Chronological age	37 years
	Effective Age	24 years
	Remaining life span	1 year
	Replacement year	2018
Unit Quantity	13ft pews	25 ea
	11ft pews	7 ea
	8 ft pews	3 ea
	13 ft pony wall	1 ea
	10 ft pews	3 ea
	7ft pews	1 ea
	2 ft pews	1 ea
	9 ft pony wall (choir)	2 ea
Current repair/replacement cost	Paint pews and trims - \$40,000 – quotation received	
Commentary	The actual pews are in good condition, but the paint finish is deteriorating. This is not an urgent issue but has been planned for an extended period. We recommend budgeting to repaint all the furniture and trims within the next year. A quotation has been received from Tod’s Furniture re-finishing to complete this work.

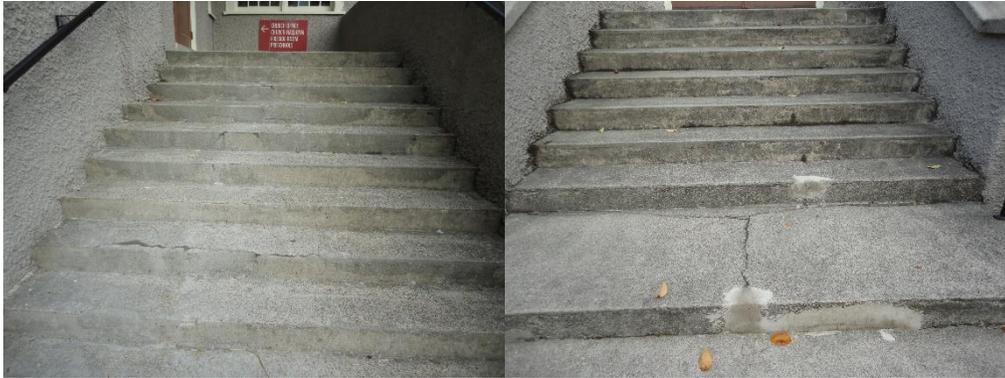
Component (32) Pedestrian Paving		
Building Component	Concrete paving	
Description	Poured concrete stairs	
Overall Condition	Poor	
Life Cycle Analysis	Installation date	1950
	Life expectancy	50 years
	Chronological age	67 years
	Effective Age	48 years
	Remaining life span	2 years
	Replacement year	2019
Unit Quantity	Concrete stairs	3 locations
Current repair/replacement cost	Demolish – 20 hrs @ \$35 per hr = \$700 Remove – 4 hr @ \$35 per hr = \$140 Disposal fee = \$250 Formwork material - \$300 Install formwork - 25 hrs @ \$35 per hr = \$825 Concrete supply - \$600 Rebar - \$200 Install concrete - \$700 Finishing and making good - \$500 Total - \$4,265 per stairs	
Commentary	The concrete stairs are showing significant signs of deterioration. They are cracking and damaged in many locations. We recommend budgeting to replace the concrete stairs. This will involve breaking out the existing stairs, removing material off site, installing new concrete and finishing.

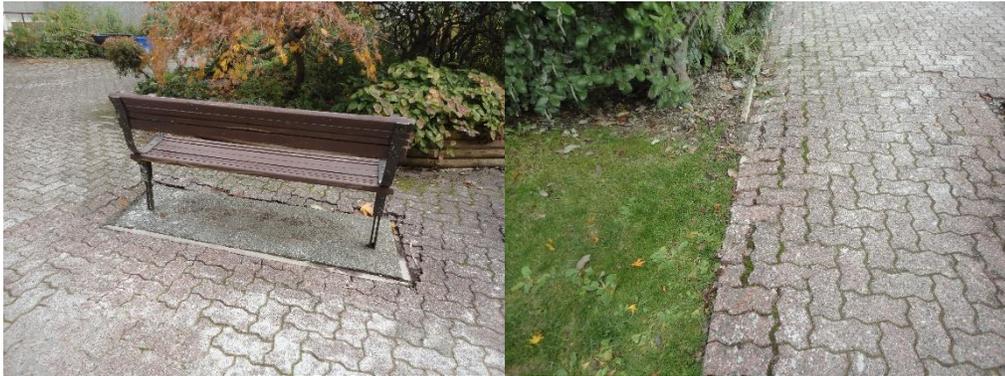
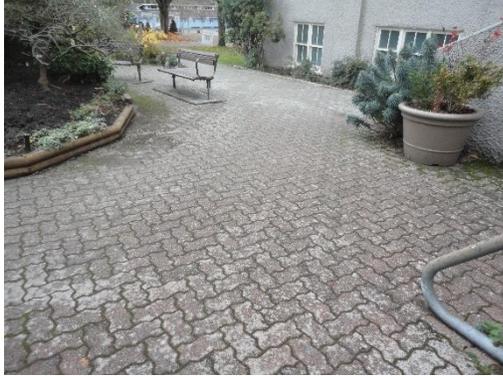
Component (33) Pedestrian Paving		
Building Component	Brick paving	
Description	Brick pedestrian paving	
Overall Condition	Fair	
Life Cycle Analysis	Installation date	1950
	Life expectancy	50 years
	Chronological age	67 years
	Effective Age	47 years
	Remaining life span	3 years
	Repair year	2020
Unit Quantity		1 item
Current repair/replacement cost	Lift and re-set paving - \$8,000	
Commentary	The paving is sinking and lifting in locations. It is old and showing signs of deterioration. We recommend budgeting to lift the paving, level ground and re-set the paving to a level position. Some pavers may need replacement. The paving is a slight trip hazard.

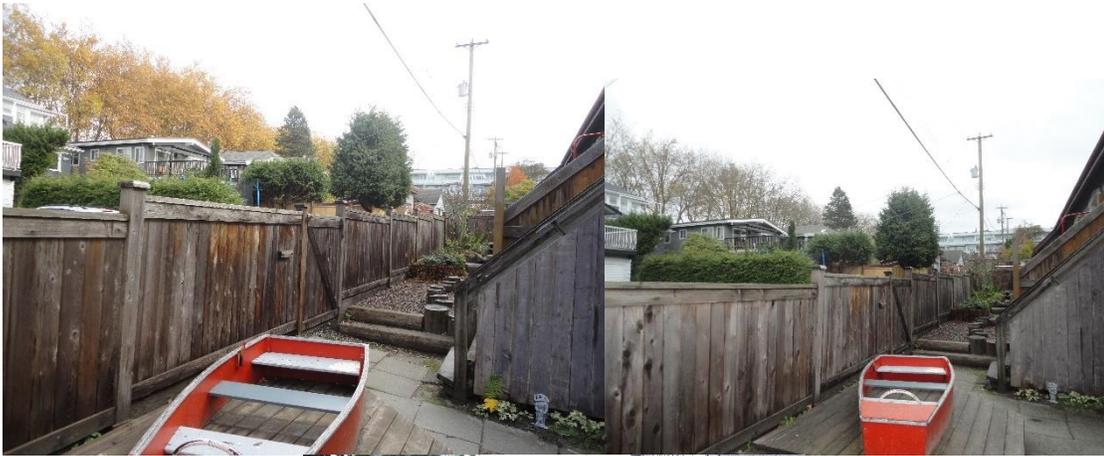
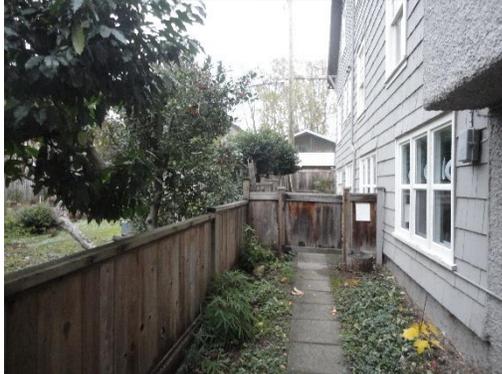
Component (34) Fencing		
Building Component	Wooden fencing	
Description	The fencing consists of 5ft high wooden fencing	
Overall Condition	Good	
Life Cycle Analysis	Installation date	2004
	Life expectancy	25 years
	Chronological age	13 years
	Effective Age	13 years
	Remaining life span	12 years
	Replacement year	2029
Unit Quantity		220 lf
Current repair/replacement cost	Supply and install fencing - \$6,600	
Commentary	No major defects were observed or reported. The fencing is performing satisfactorily. It requires painting. Any repairs and painting can be considered under operations and maintenance.

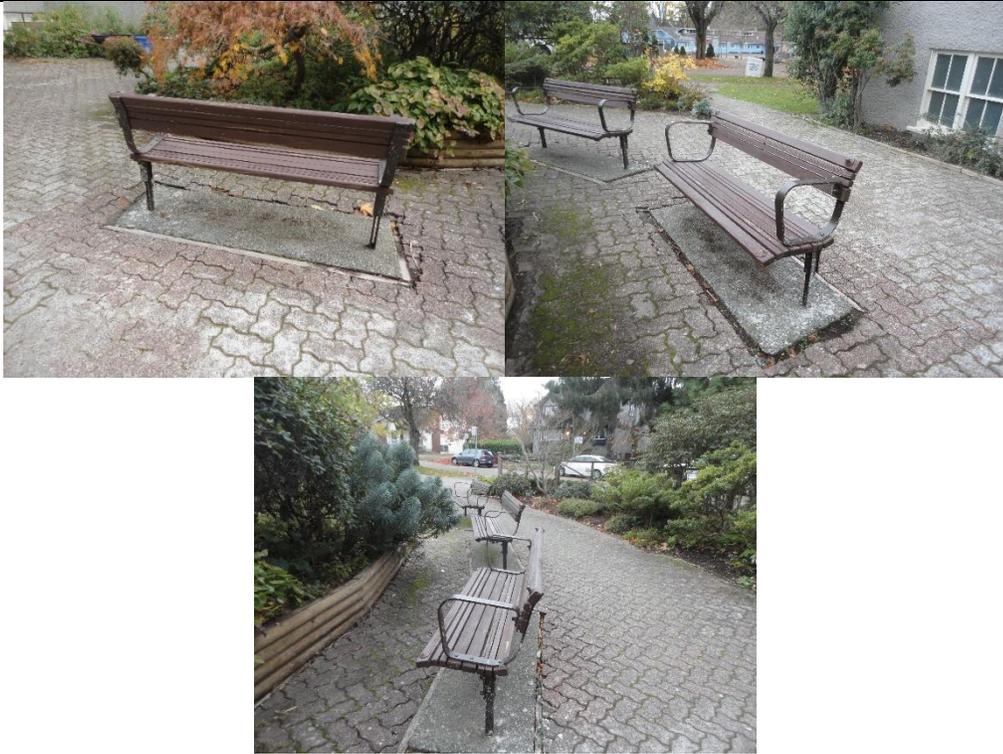
Component (35) Site Furniture		
Building Component	Wooden seating	
Description	Wooden benches	
Overall Condition	Good	
Life Cycle Analysis	Installation date	1980
	Life expectancy	35 years
	Chronological age	37 years
	Effective Age	30 years
	Remaining life span	5 years
	Replacement year	2022
Unit Quantity	Wooden benches	4 ea
Current repair/replacement cost	Supply and install benches - \$1,000 per bench	
Commentary	The benches are old but are functioning without issue. They have past design life expectancy. However, they are expected to last another five years.

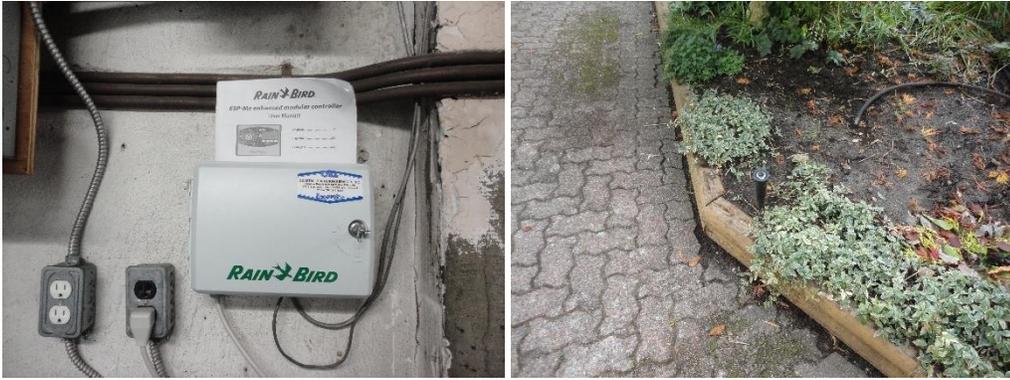
Component (36) Irrigation System													
Building Component	Irrigation sprinkler system												
Description	The sprinkler system consists of a Rain Bird irrigation sprinkler system.												
Overall Condition	Good												
Life Cycle Analysis
