Camp Puntchesakut

Present facilities

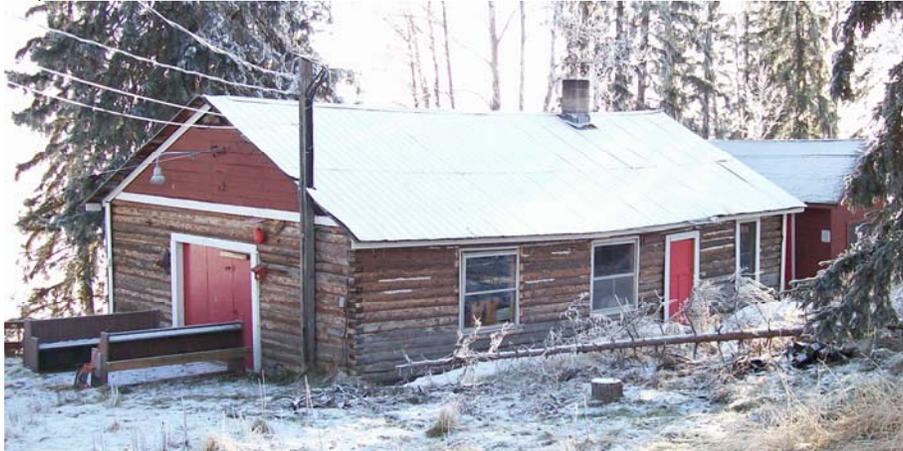
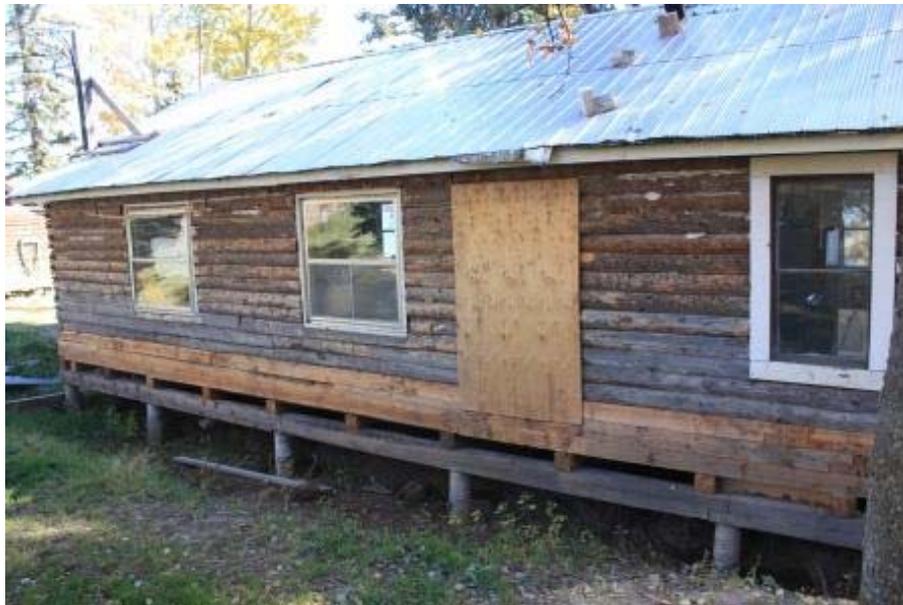
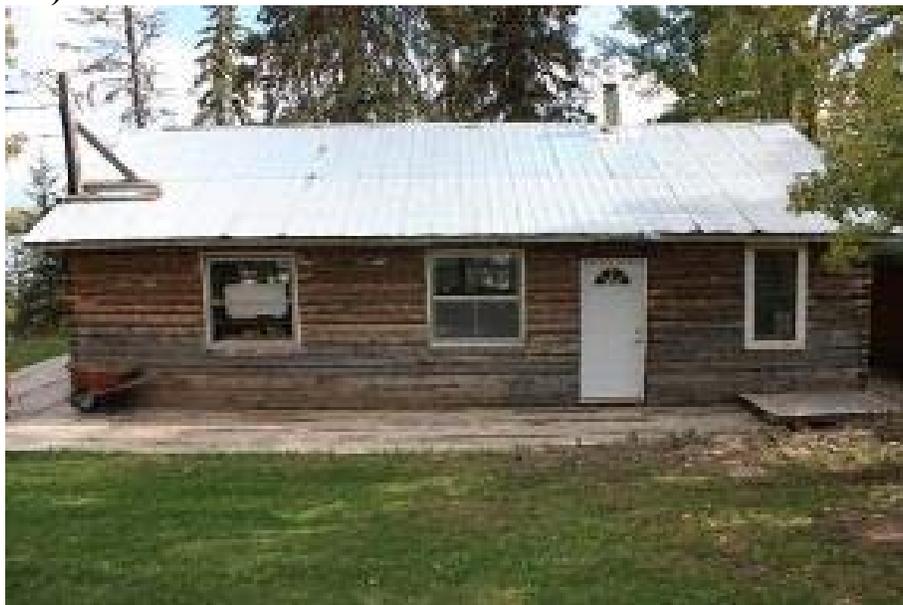
Chuckwagon – Dining Hall/Kitchen

This building was raised with new footings and concrete foundation posts installed along with replacing the lower walls. A new floor was installed and a new metal chimney replaced the previous masonry chimney. One new door was installed. All of the power for the camp goes through the electrical distribution panels in the Dining Hall. There is an electrical inspection certificate posted on the wall, however, much of the electrical system should be updated even though there are no significant safety concerns. The kitchen, although simple, does meet health standards and this has been confirmed with a formal inspection by the Health Inspector. The dining area can seat about 50 people on benches.

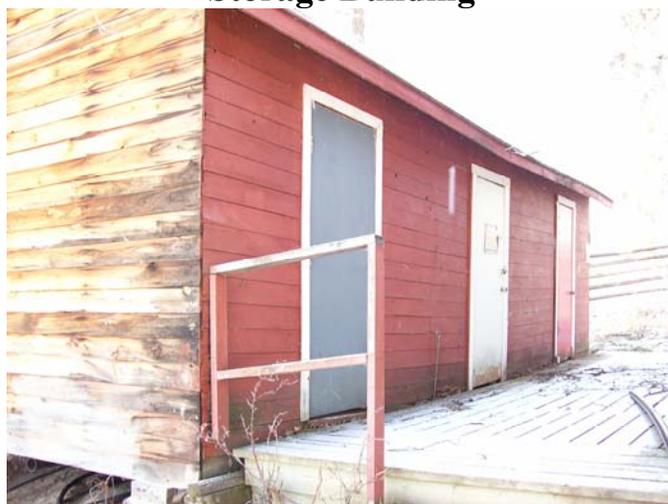
Storage Building

The storage building houses a small workshop and a storage room and a laundry room. The building is built on concrete pier blocks and has been protected on the Northwest wall by a wooden retaining wall. The floor assembly and foundation on the West side are completely rotted out. The building has been jacked up for the doors to open properly. There is a porch that joins the storage building to the Chuckwagon and it is in good condition. Other than maintenance, there has been no restoration work done to this building yet.

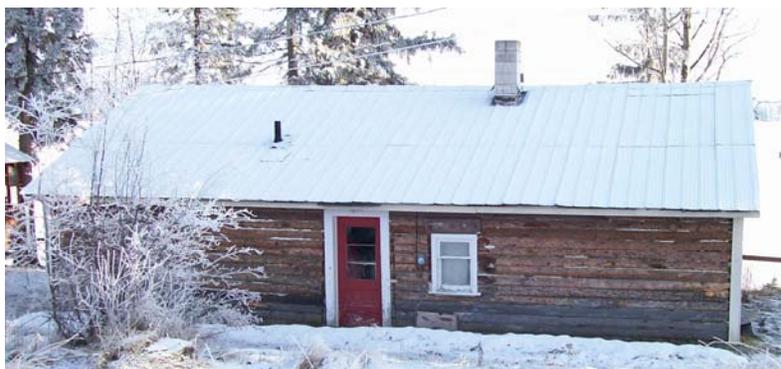
Before:

The staff cabin had four bedrooms, a common seating area, a full bathroom and a first aid room with a small woodstove that supplied the only heat for the cabin. The building was raised and most of the interior walls did not survive. New footings and foundation posts similar to the Dining Hall were installed. The existing doors were removed and new wider doors installed. The masonry chimney also did not survive and a new metal chimney was installed. The bathroom was enlarged to make handicap accessible and the shower room was separated from the bathroom with its own entrance. The remainder of the building is now used as a bunkhouse with a block wall surrounding the wood stove.

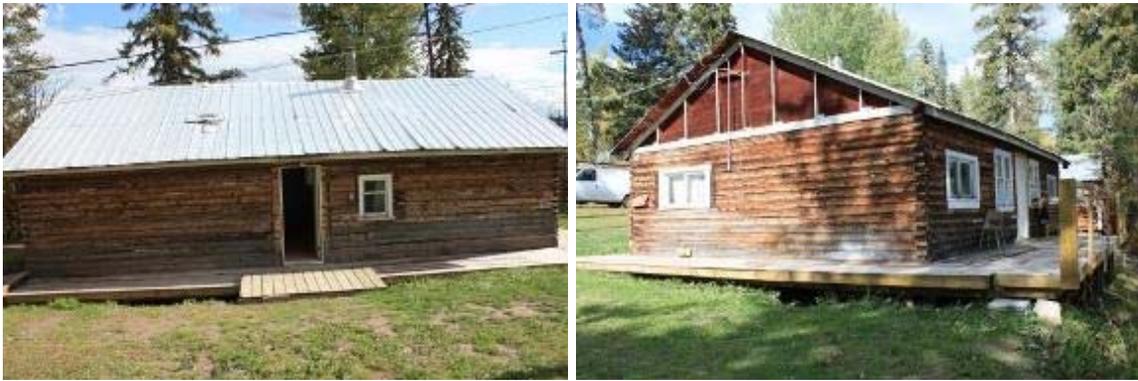
Present:

A new porch was installed on three sides of this building to provide wheelchair access and to protect the foundations.

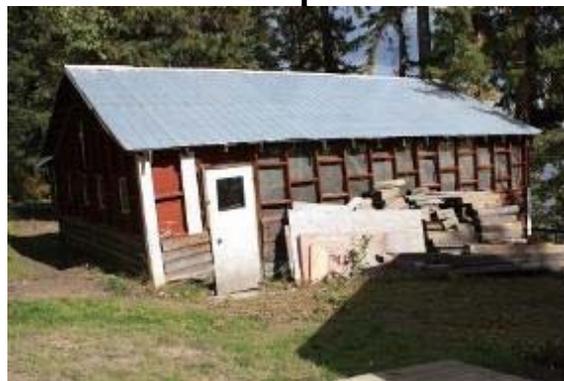
The Chapel is an open structure with one large room. It is built on a foundation of concrete pilings. There is considerable build up of dirt on the Northwest wall which has compromised the door on the Northeast side which is unusable. There is serious deterioration of the bottom logs, however, there is no settling. The building is currently being used for storage.

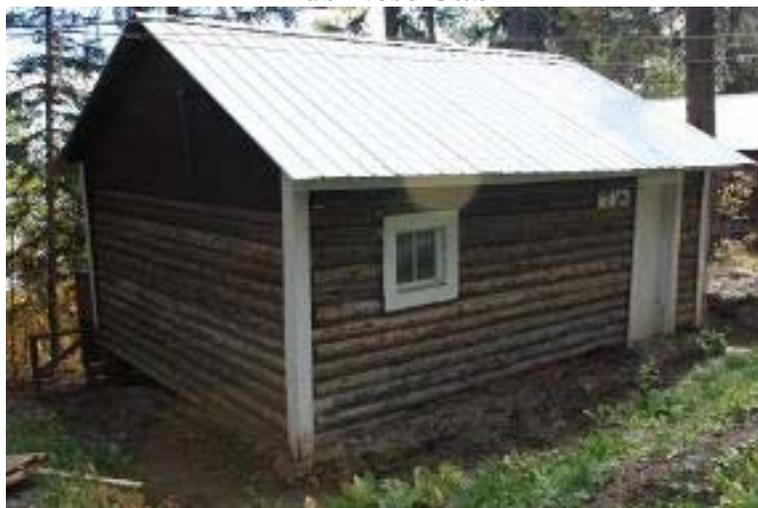
Birds Nest Cabin

Also known as the Bishop's Cabin, it has one bedroom, a bathroom and a sitting area. It has no heat as the unsafe woodstove was removed when the new metal roofing was installed. The building is built on creosote pilings and also has dirt build up along the Northwest wall. The building has been prepared for raising this Spring.

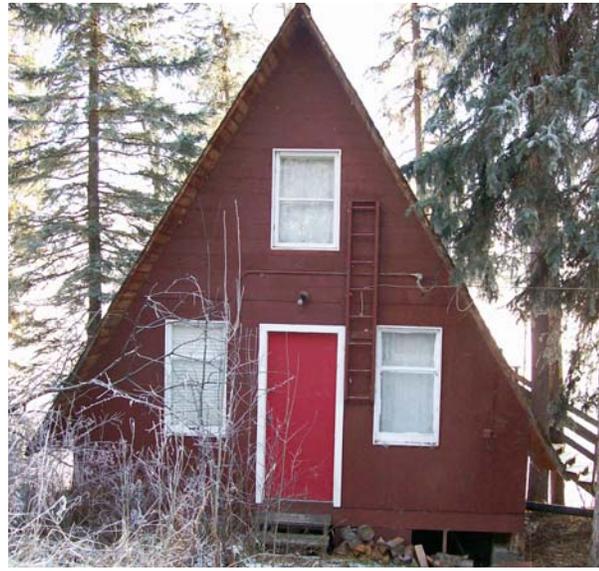
A Frame

The A-Frame is the newest sleeping accommodation constructed on the property and consists of a large storage area under the building, one bedroom, bathroom, sitting area and small kitchen on the main floor and two bedrooms in the loft. The building is heated with a certified woodstove venting into a “Class A” stainless steel chimney. There is a fire escape ladder on each end of the building from the loft area. The building is built on a concrete foundation and supported on concrete blocks. The roof is asphalt tiles which appear to be in good condition. The building is in good condition overall and is showing no signs of deterioration or settling.

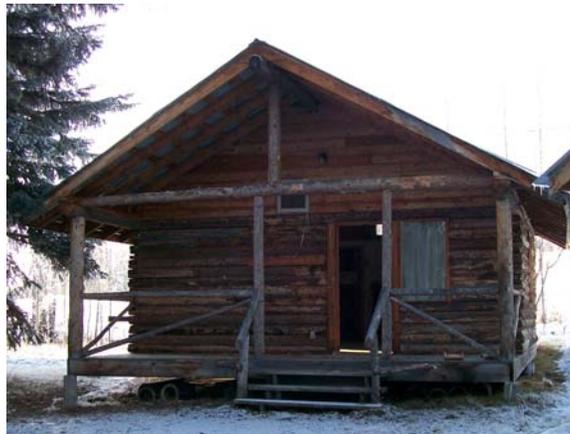
Cabin 1

The first of the three campers cabins was previously rebuilt by constructing a foundation of concrete “sono tubes” and building a new floor platform that extended beyond the original footprint creating a front porch. The log walls were then rebuilt on top of the new platform and a new roof completed the structure. The inside is refinished with a linoleum floor and gyproc walls. The building is heated with two 500W baseboard heaters that are thermostatically controlled. The building is in good condition and is showing no signs of deterioration or settling.

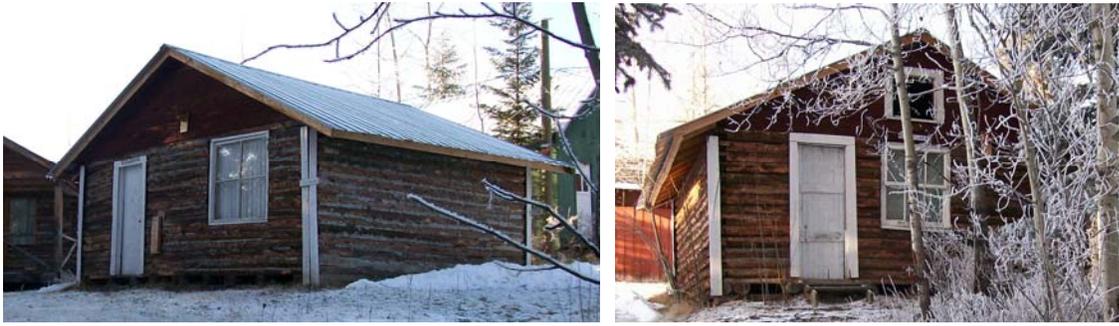
Cabins 2 and 3

These two cabins will be discussed together as they are basically identical. There is no foundation for either building other than the logs directly on the ground, however, there is minimal signs of deterioration or settling. The interior of both cabins are rustic to say the least with a plank floor and rough hewn logs. Both cabins will require foundation work to prevent future deterioration. There is no heat in either cabin although there is a basic electrical service.

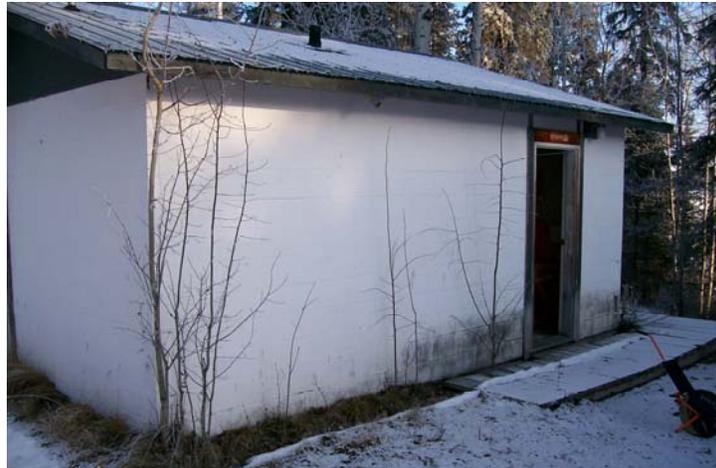
Wash House

The concrete block washhouse is the most solid building on the property. There are separate facilities for males and females and a small service room at one end that houses two hot water tanks, a water pressure tank and the well head. This room also has an electrical panel. The Gents washroom has three sinks, two toilets in private stalls and shower in a private room. The Ladies side has four sinks, two toilets in private stalls and a shower in a private room.

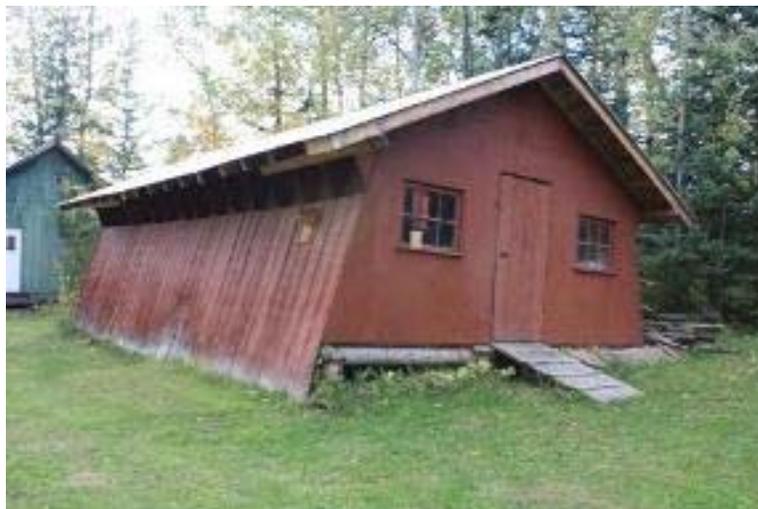
The Craft House is one large room that is used for craft storage and a workshop. The building sits on creosote pilings and shows no signs of settling. The roof was replaced with a new metal roof. There is no heat in this building.

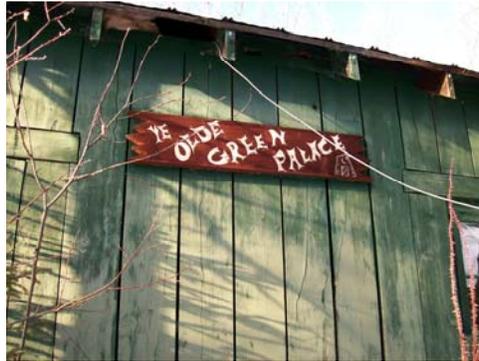
Olde Green Palace

This building was originally planned to house the camp cooks. There is an abandoned water tank in the attic that is accessed by a steep stairway from the sitting room. There is one bedroom and a roughed in bathroom that has not been completed. The building sits on a 6x6 timber for a foundation, but there is no signs of settling, however both entrance porches have seriously deteriorated. There is no heat source for this building.

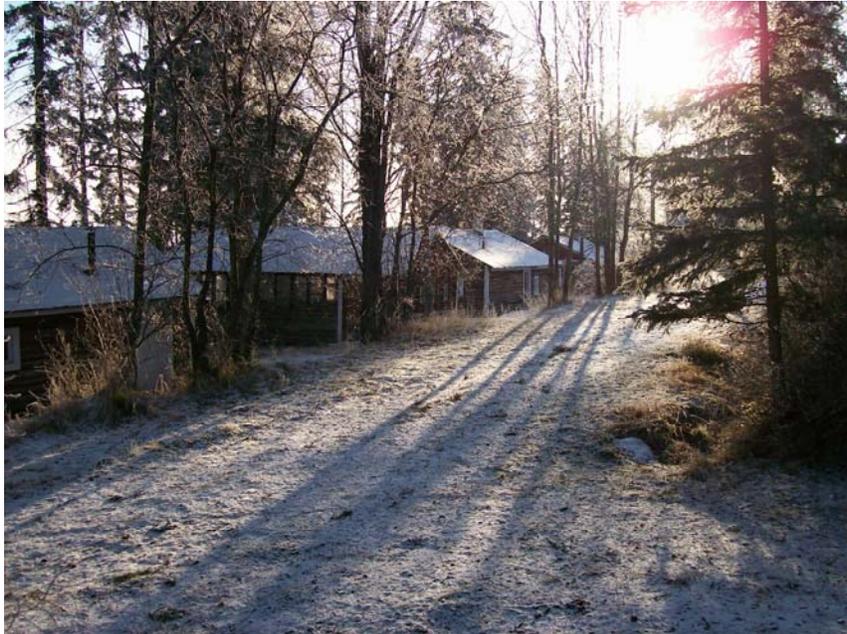
General

All the existing water lines and tanks are in fair condition. The system holds water pressure well, but many of the lines run above ground and should eventually be buried for protection.

The Sewer System is in good working condition and one of the sewer pumps has been replaced. The structure over the septic tank was rebuilt last year.

Electrical power is provided to each of the buildings on the property. Eventually these lines should be relocated underground for protection.
